# 9604 Hillhaven Ave. Arborist Report

Prepared for SEC Development  
c/o Vardan Kasemyan

**Prepared by James Komen**  
BCMA WE-9909B  
RCA #555

April 14, 2023

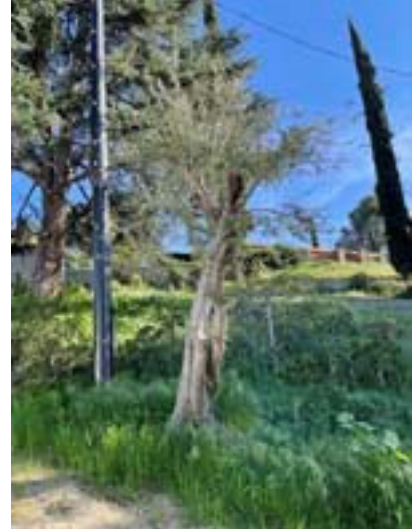
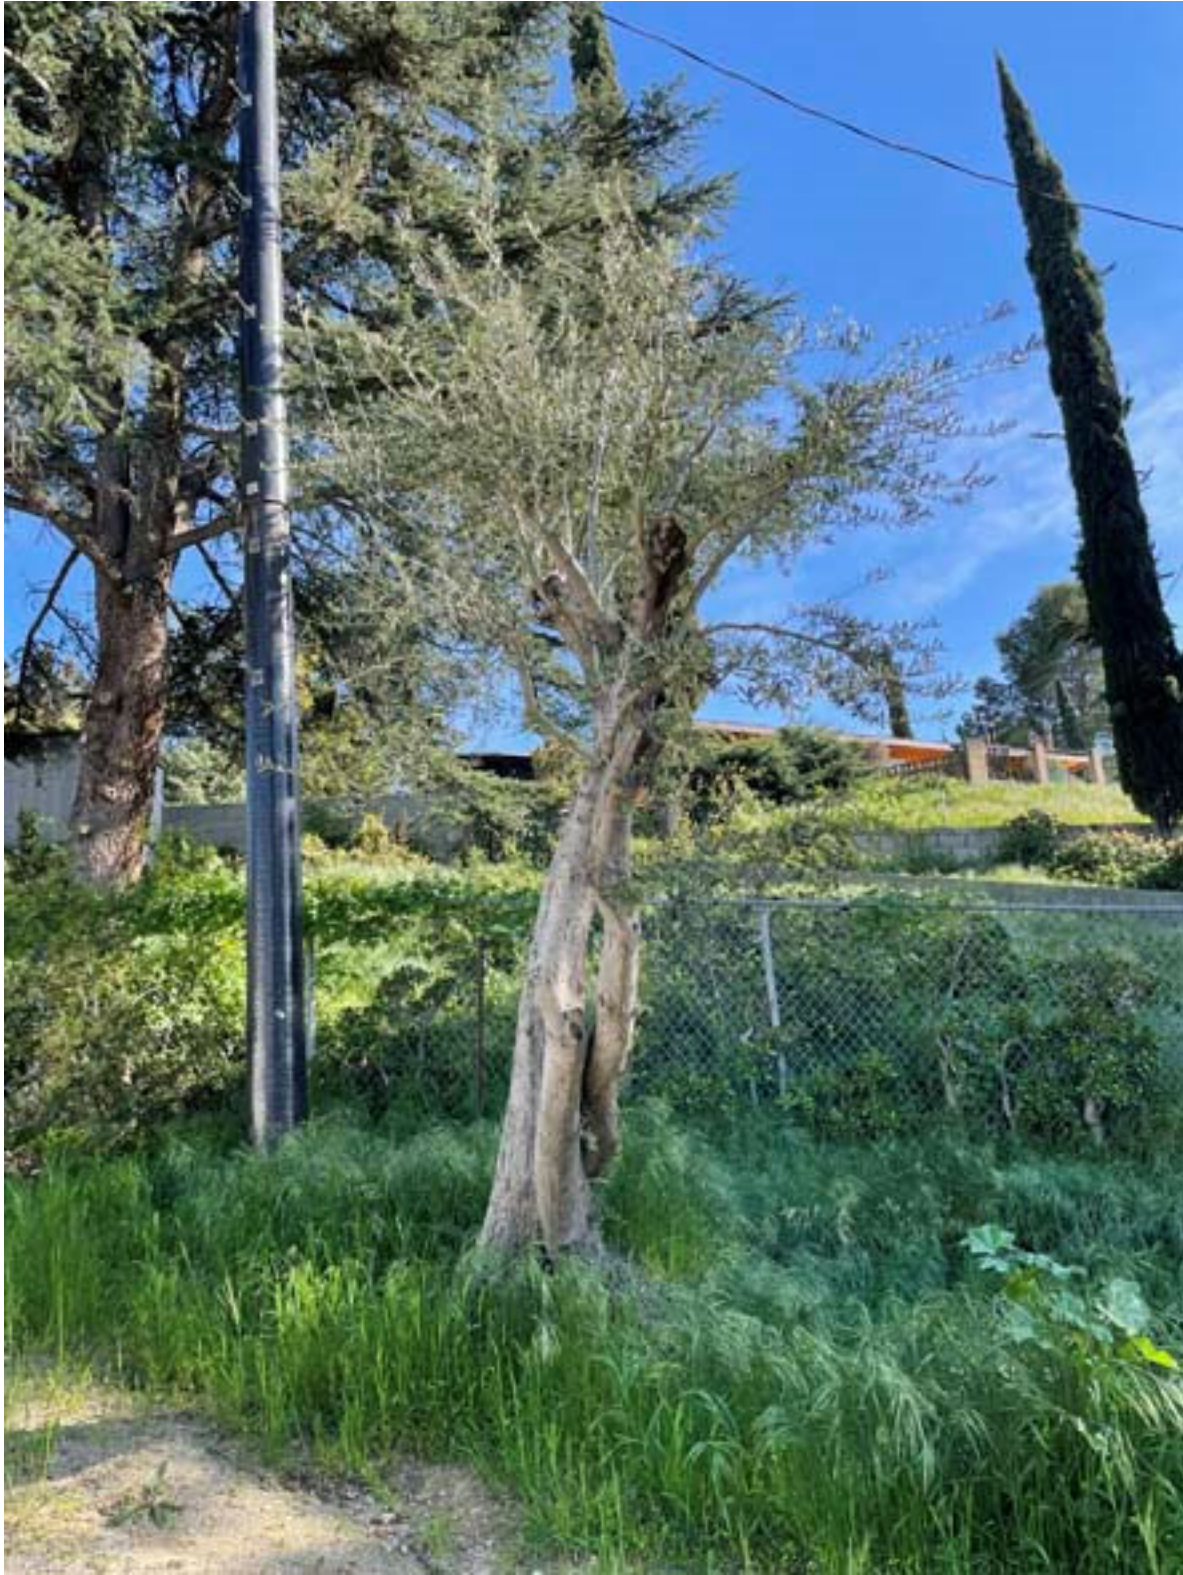
**Figure 1: Tree 1**

<p><b>Tree 1</b> <i>Olea europaea</i> – Olive Tree</p> <p>This tree is not protected by ordinance. It will be retained in the landscape.</p> <p>This tree has a history of being pruned with topping cuts, but it is resprouting. No treatment is recommended at this time.</p>

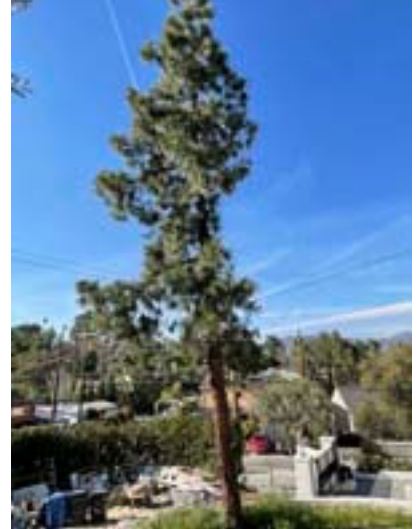
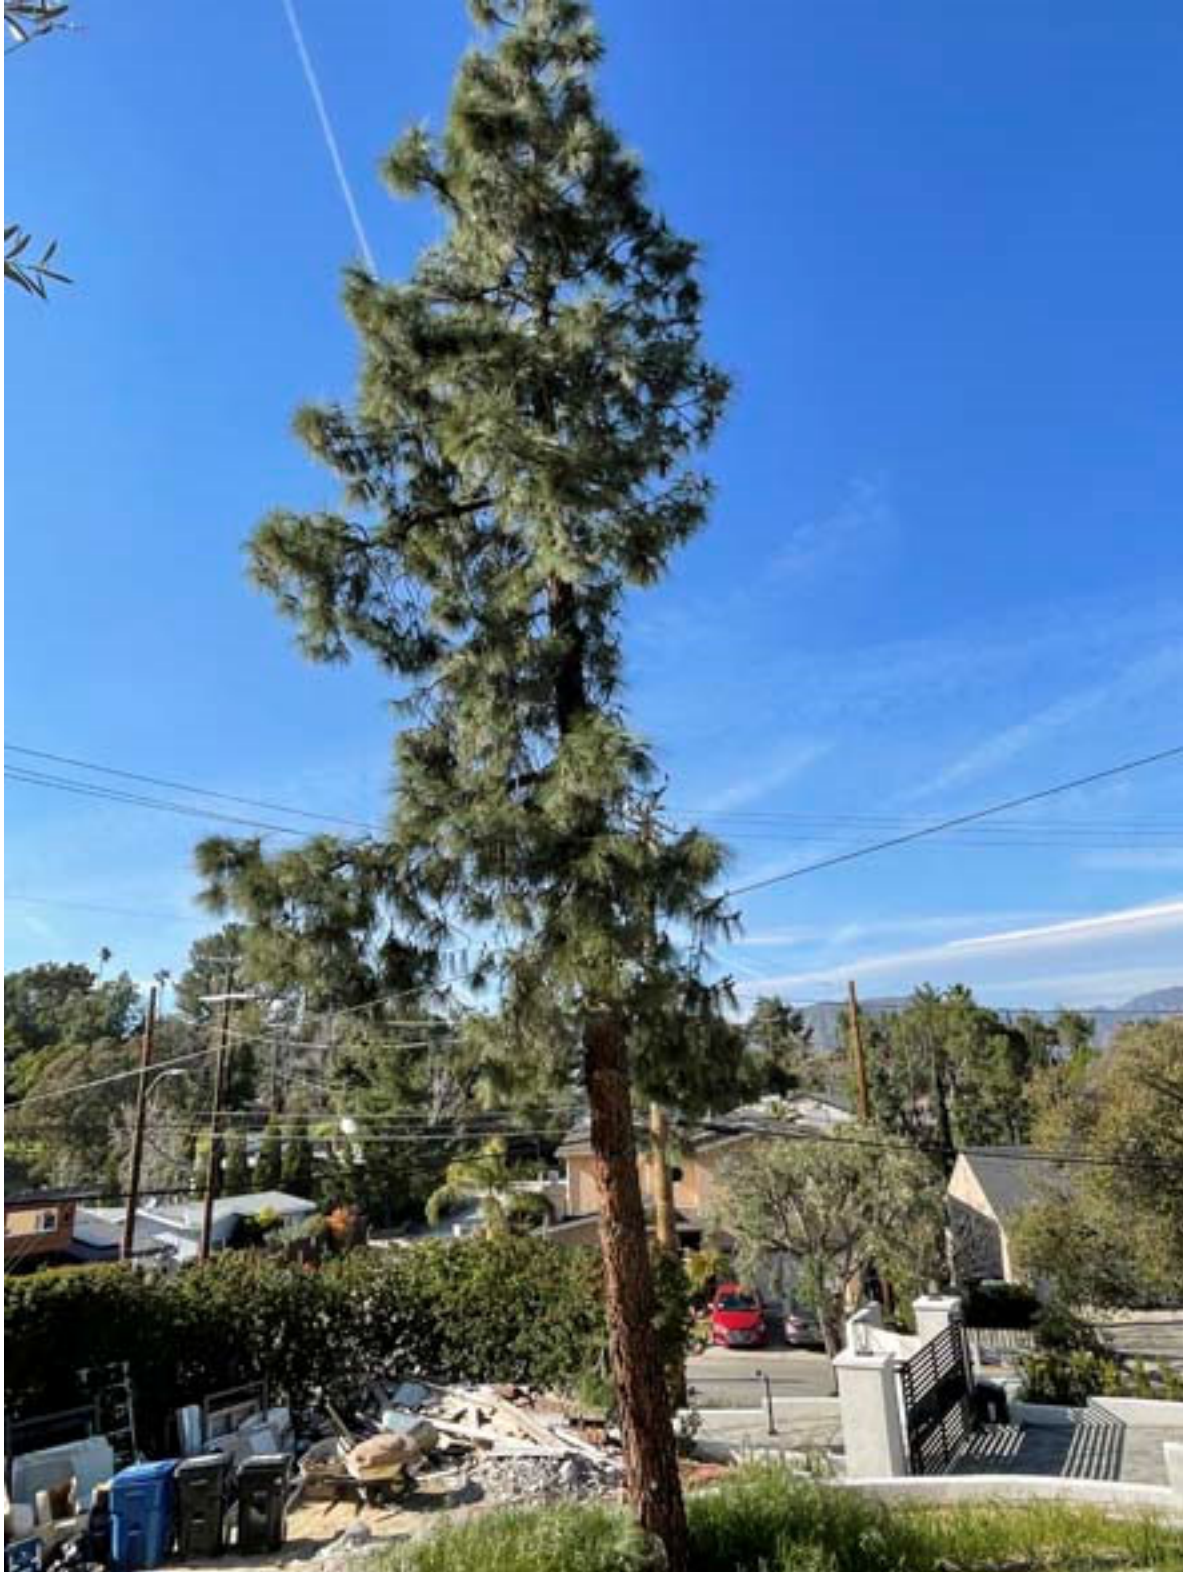
**Figure 2:** Tree 2

<p><b>Tree 2</b> <i>Pinus canariensis</i> – Canary Island Pine</p> <p>This tree is not protected by ordinance. It will be retained in the landscape.</p> <p>This tree has symptoms of heat and drought stress. I recommend applying supplemental irrigation. Moisten the soil within 20 feet of the trunk to a depth of 6-12 inches twice per month from March through October. I also recommend applying a layer of coarse bark mulch over the soil surface to a depth of 2-4 inches.</p>

- Apply a layer of coarse bark mulch over the surface of the soil within 20 feet of the trunk of Tree 2 to a depth of 2-4 inches.
- Irrigation:
  - Provide supplemental irrigation to Tree 2. Moisten the soil within 20 feet of the trunk to a depth of 6-12 inches twice per month from March through October.

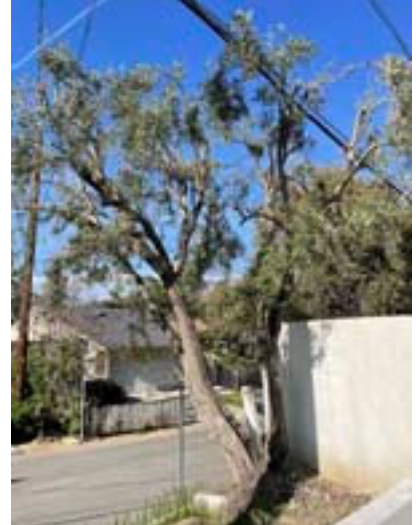
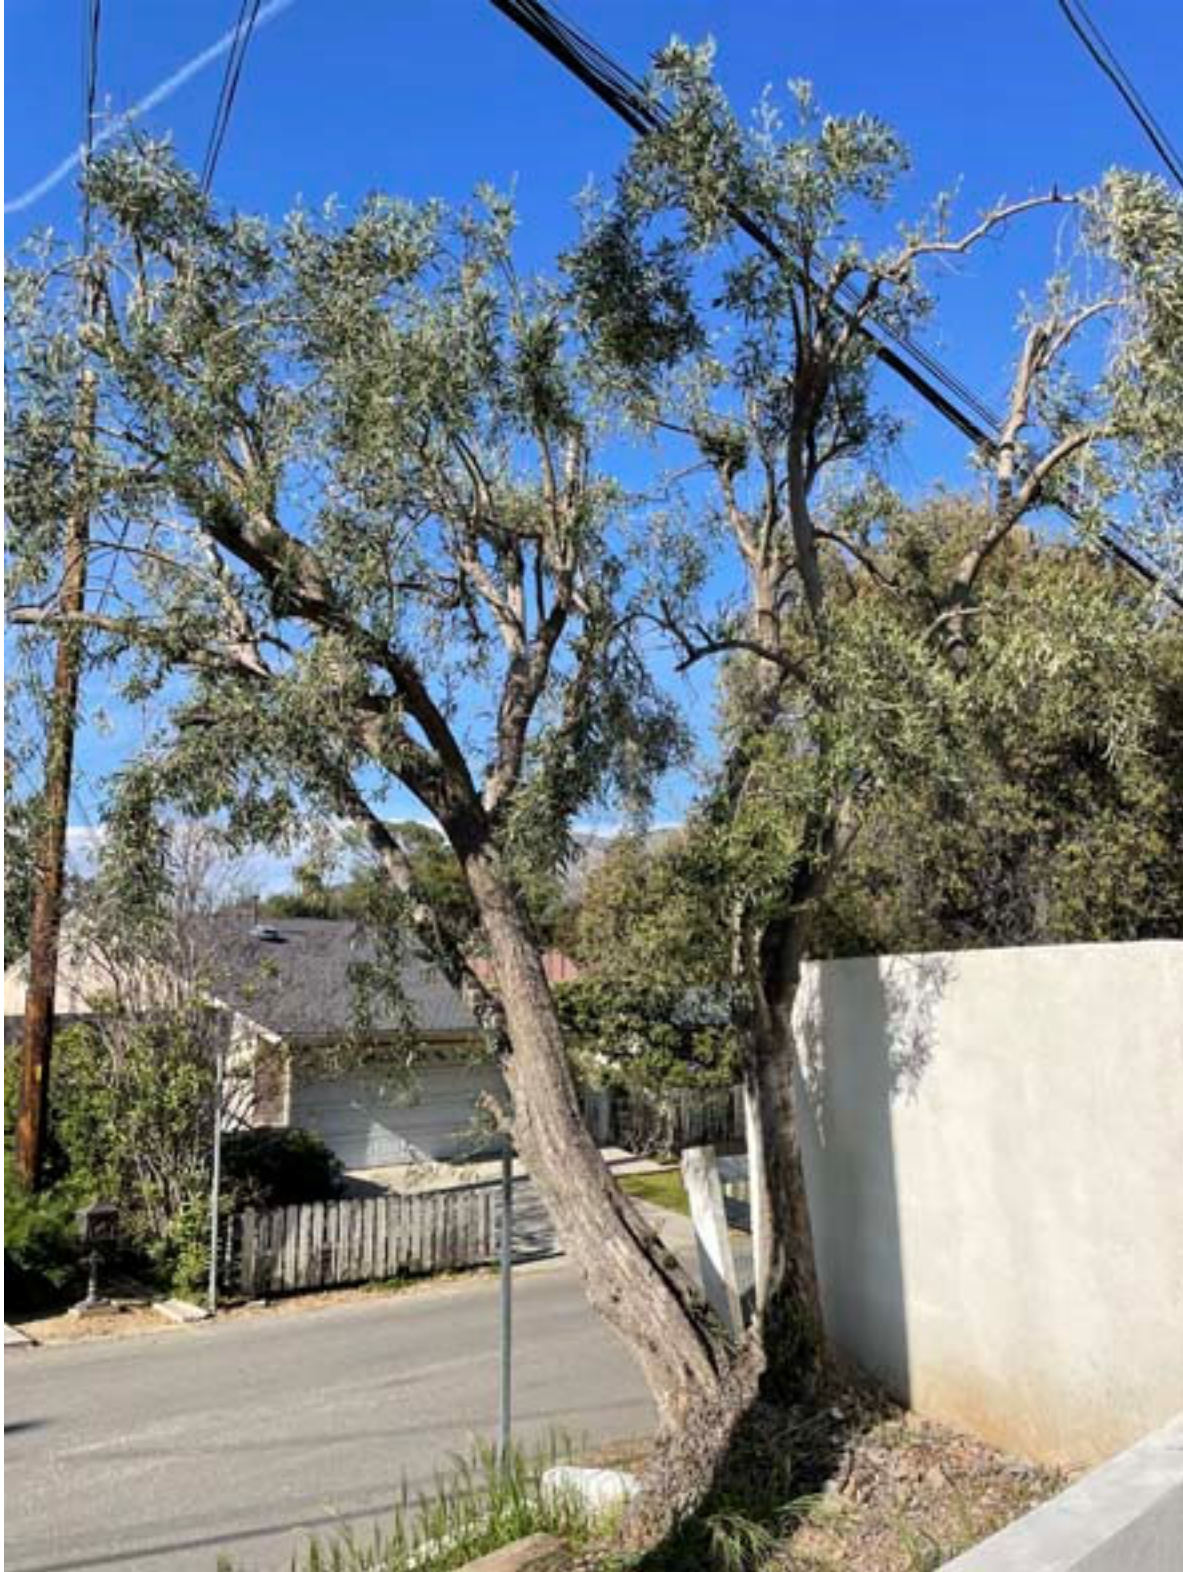
**Figure 3:** Tree 3

<p><b>Tree 3</b> <i>Olea europaea</i> – Olive Tree</p> <p>This tree is not protected by ordinance. It will be retained in the landscape.</p> <p>This tree has a history of being pruned with topping cuts. Its foliage has symptoms of heat and drought stress. Its upper branches are contacting the overhead utility lines. I recommend contacting the utility company to alert them of the need to prune to establish minimum clearance.</p>

- Removals:
  - The stump of Tree 15 may be removed, or it may be allowed to decompose into the ground.
- Pruning:
  - Inform the utility company that Trees 3-6 and 9-11 are in contact with the low-voltage utility lines and that clearance pruning is recommended. Only a qualified line clearance tree trimmer may prune trees within 10 feet of the lines.

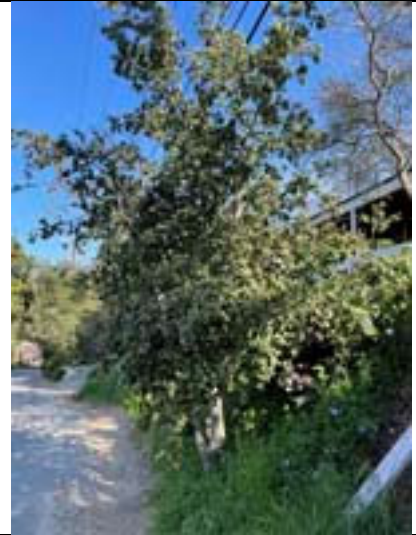
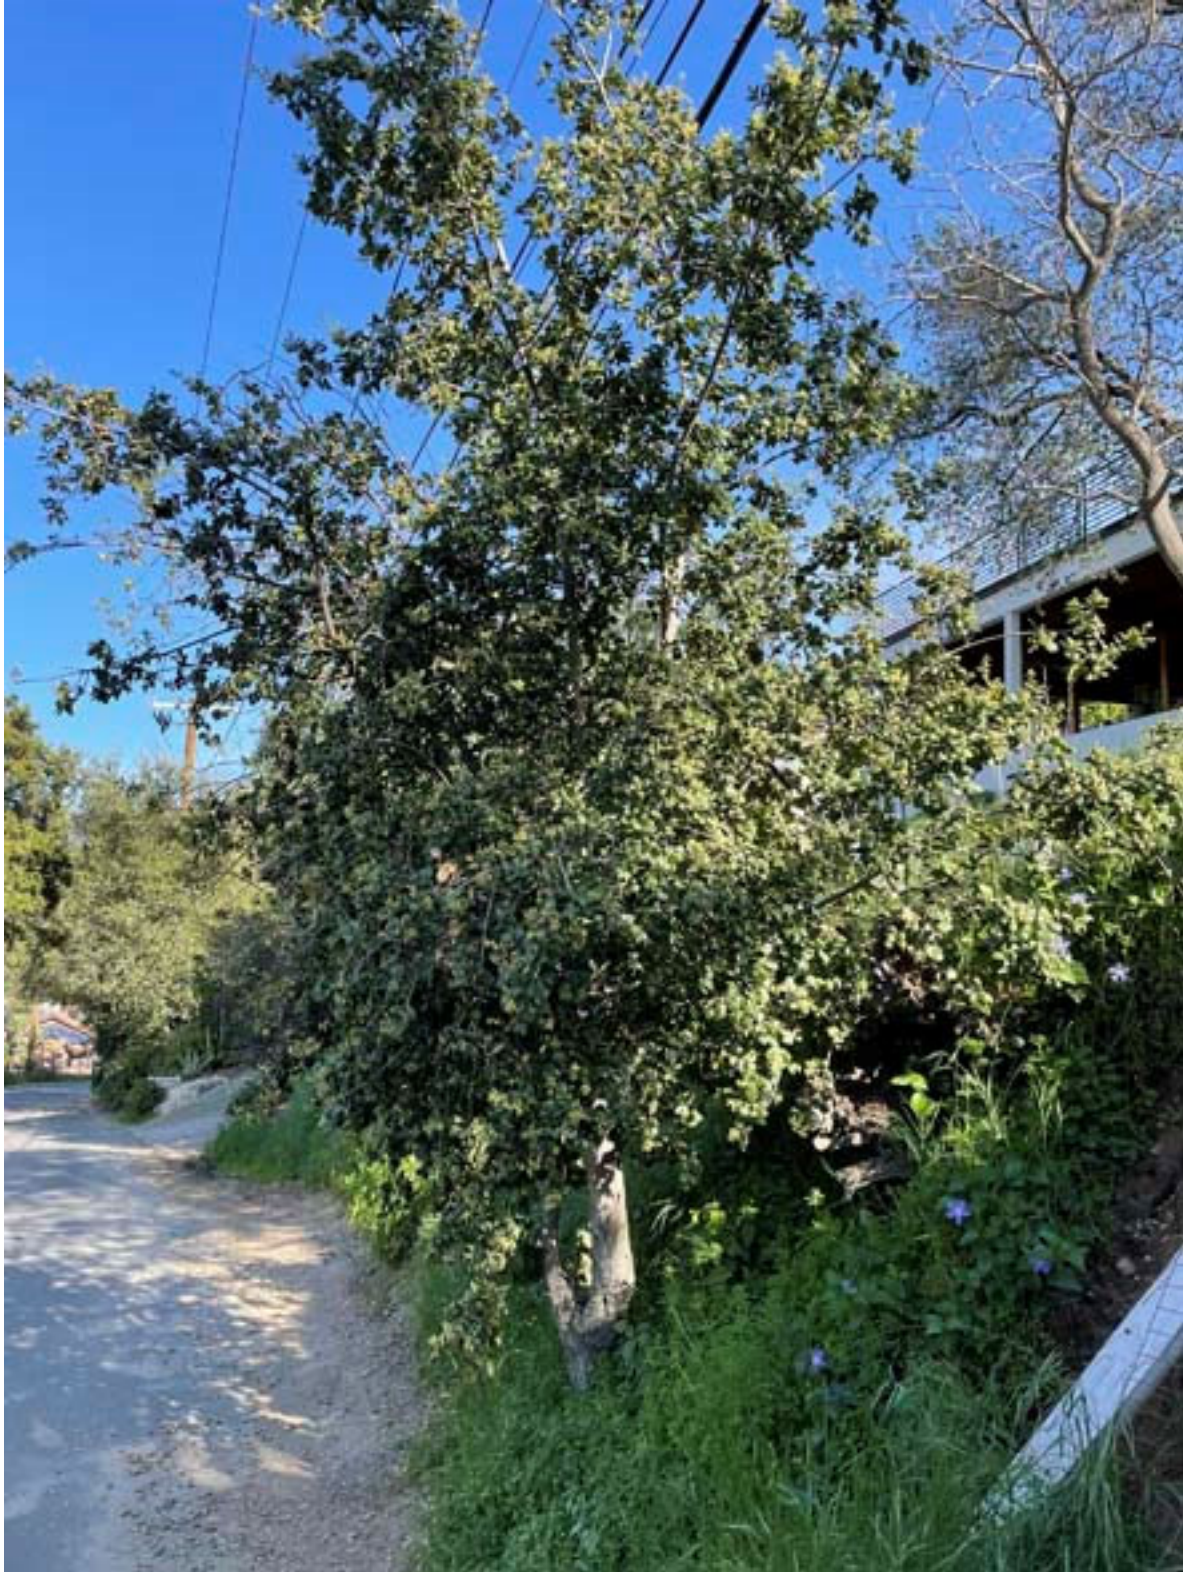
**Figure 7:** Tree 7

<p><b>Tree 7</b>  <i>Quercus agrifolia</i> – Coast Live Oak</p> <p>This is a protected native tree per Ordinance 186,873. It is growing within the public right of way. It will be retained in the landscape.</p> <p>This tree is healthy. No treatment is recommended at this time.</p>

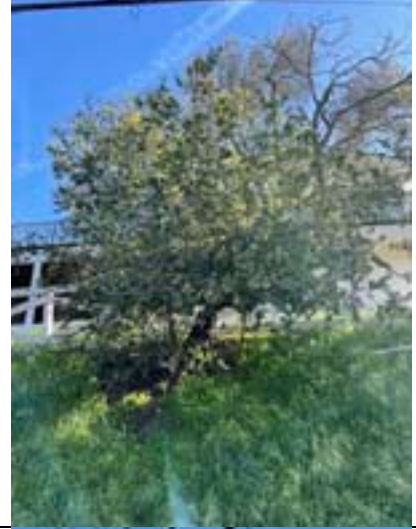
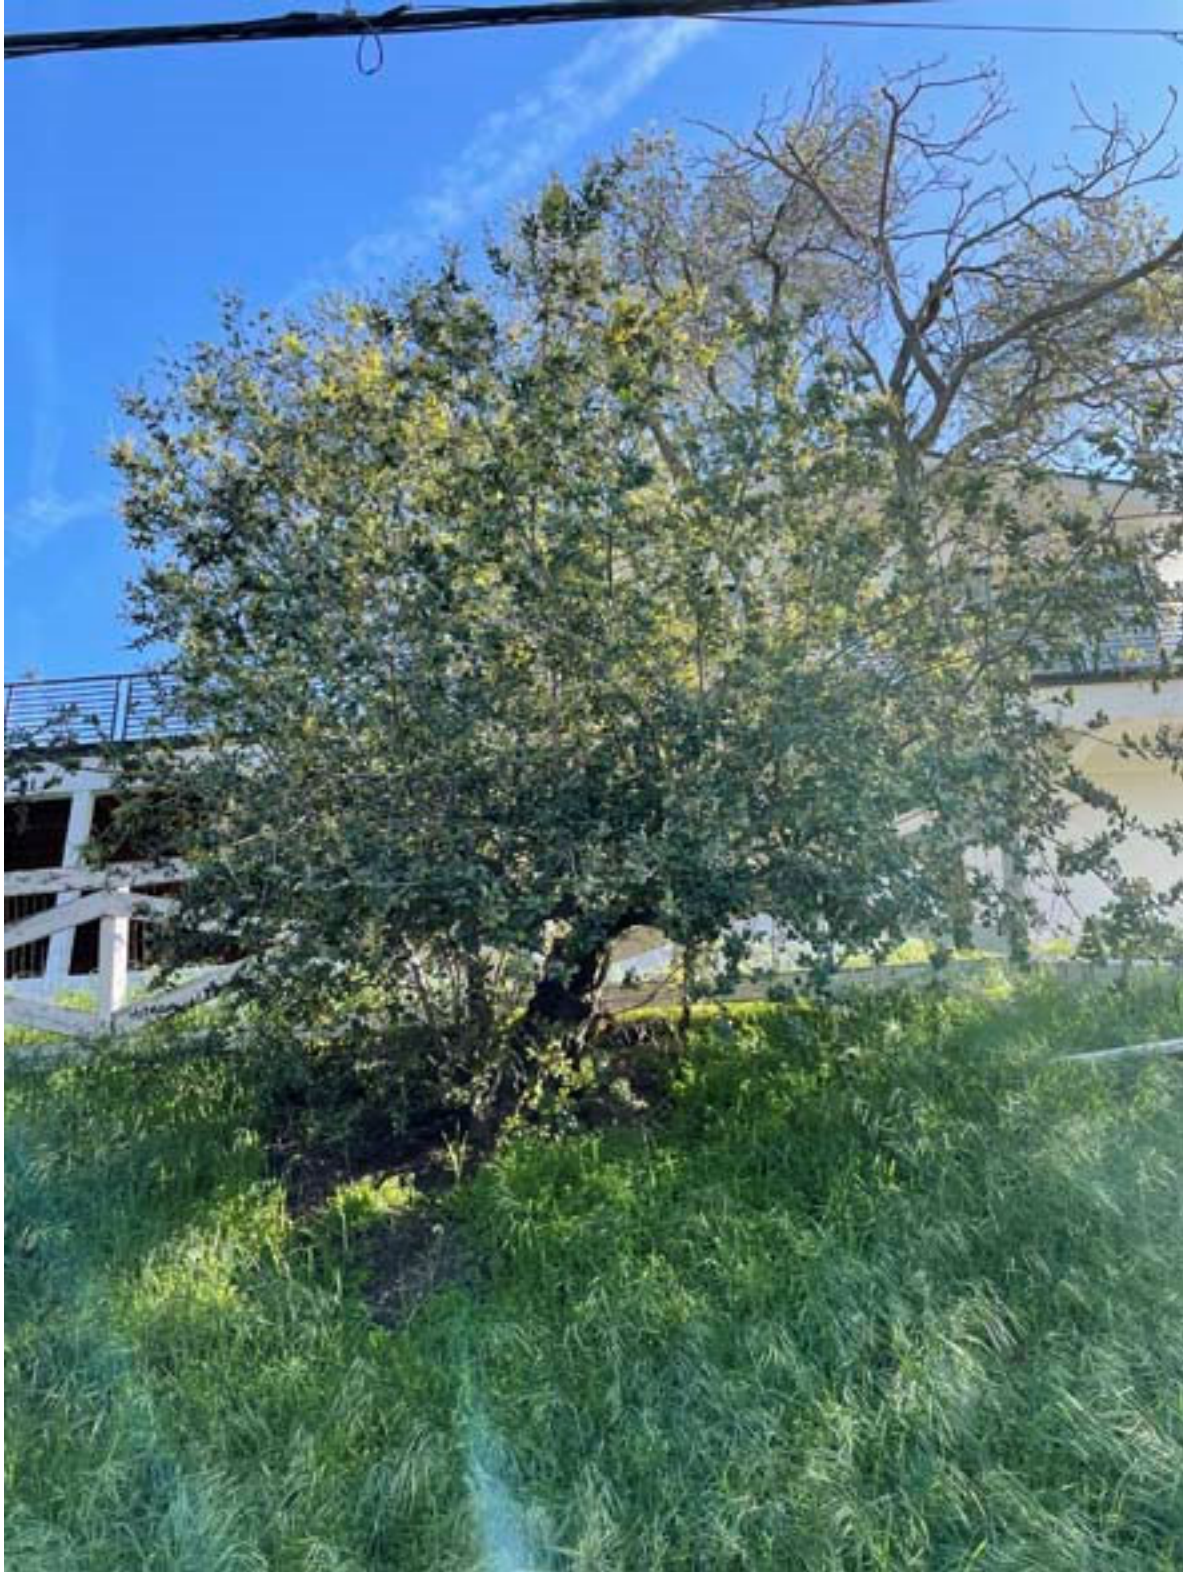
**Figure 8:** Tree 8

<p><b>Tree 8</b>  <i>Quercus agrifolia</i> – Coast Live Oak</p> <p>This is a protected native tree per Ordinance 186,873. It will be retained in the landscape.</p> <p>This tree has a decaying main stem, but it is vigorously resprouting from it. No treatment is recommended at this time.</p>

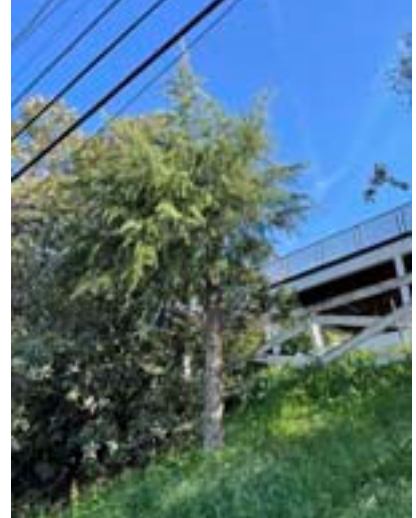
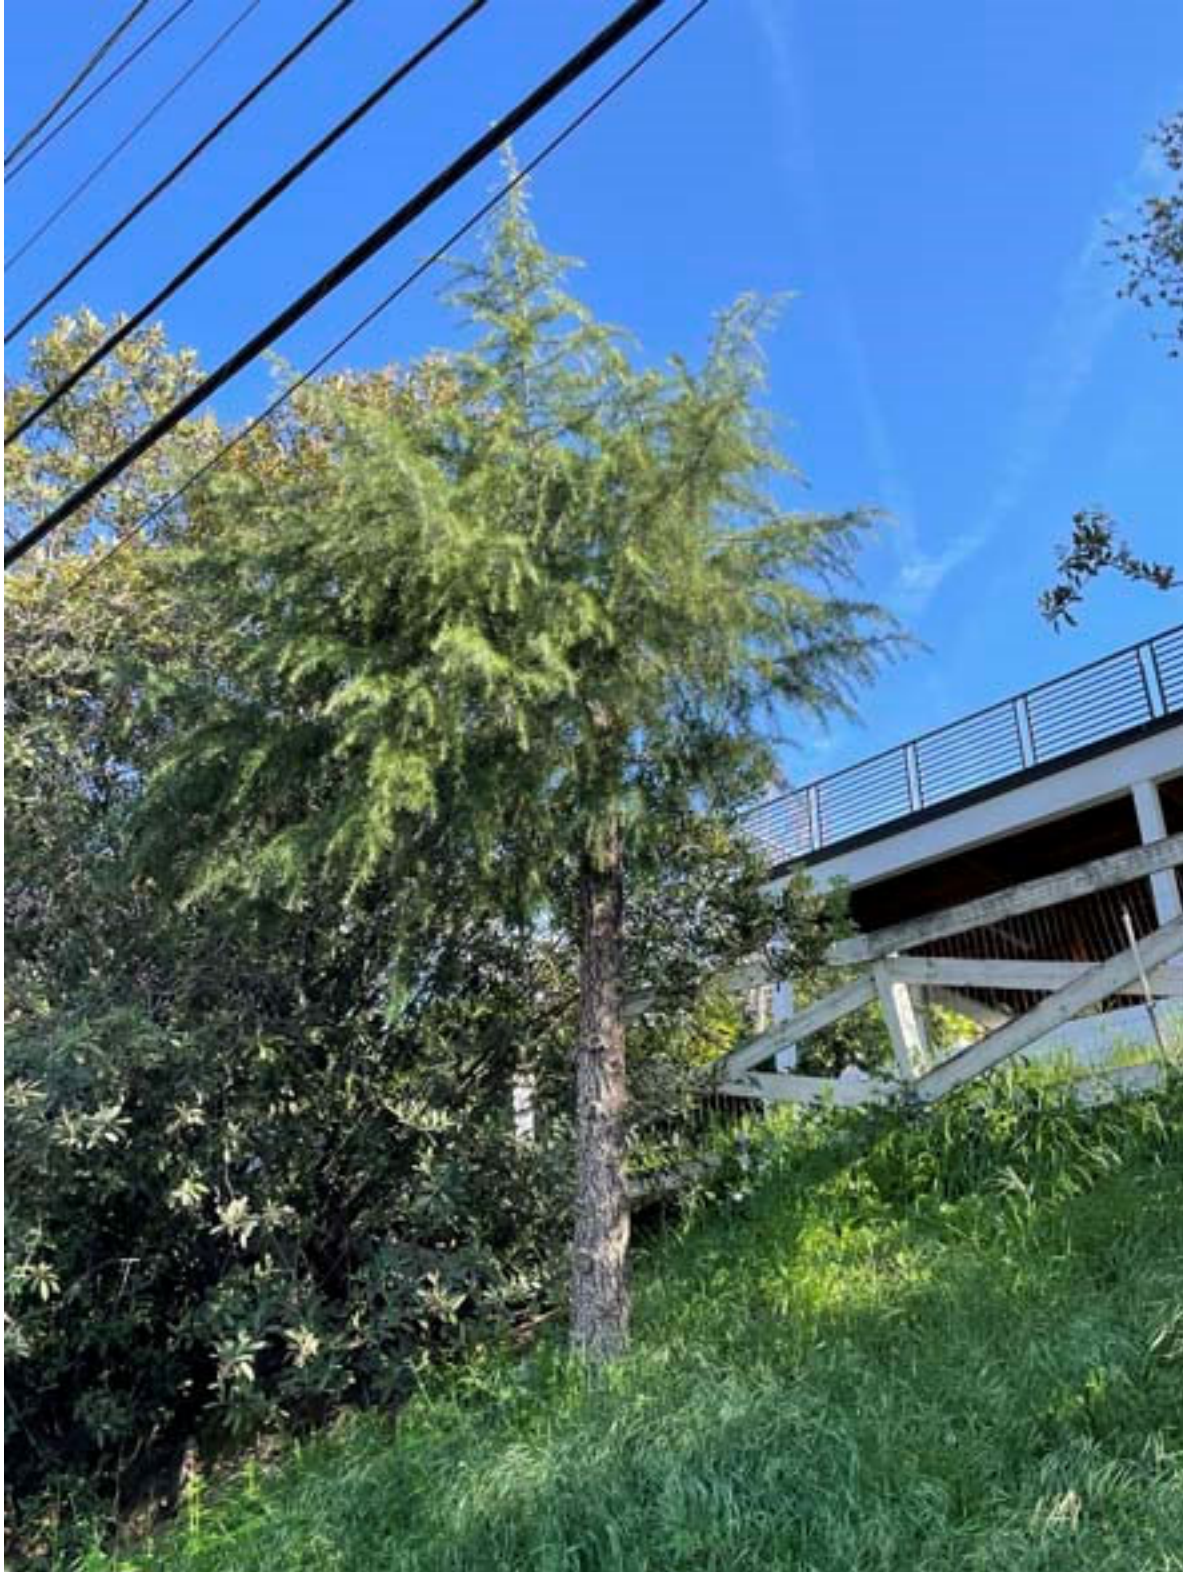
**Figure 9:** Tree 9

<p><b>Tree 9</b>  <i>Cedrus deodara</i> – Deodar Cedar</p> <p>This tree is not protected by ordinance. It will be retained in the landscape.</p> <p>This tree has a history of being pruned with topping cuts, but it is still alive despite the past pruning. Its upper branches are contacting the overhead utility lines. I recommend contacting the utility company to alert them of the need to prune to establish minimum clearance.</p>

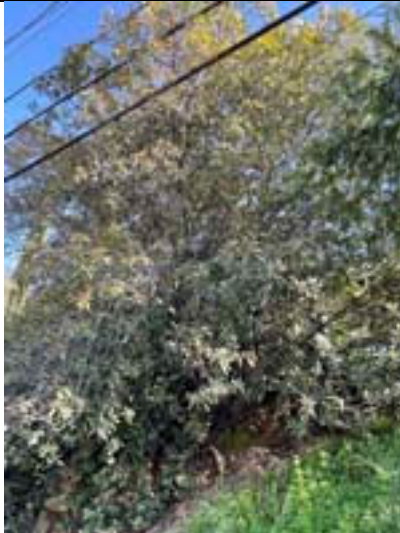
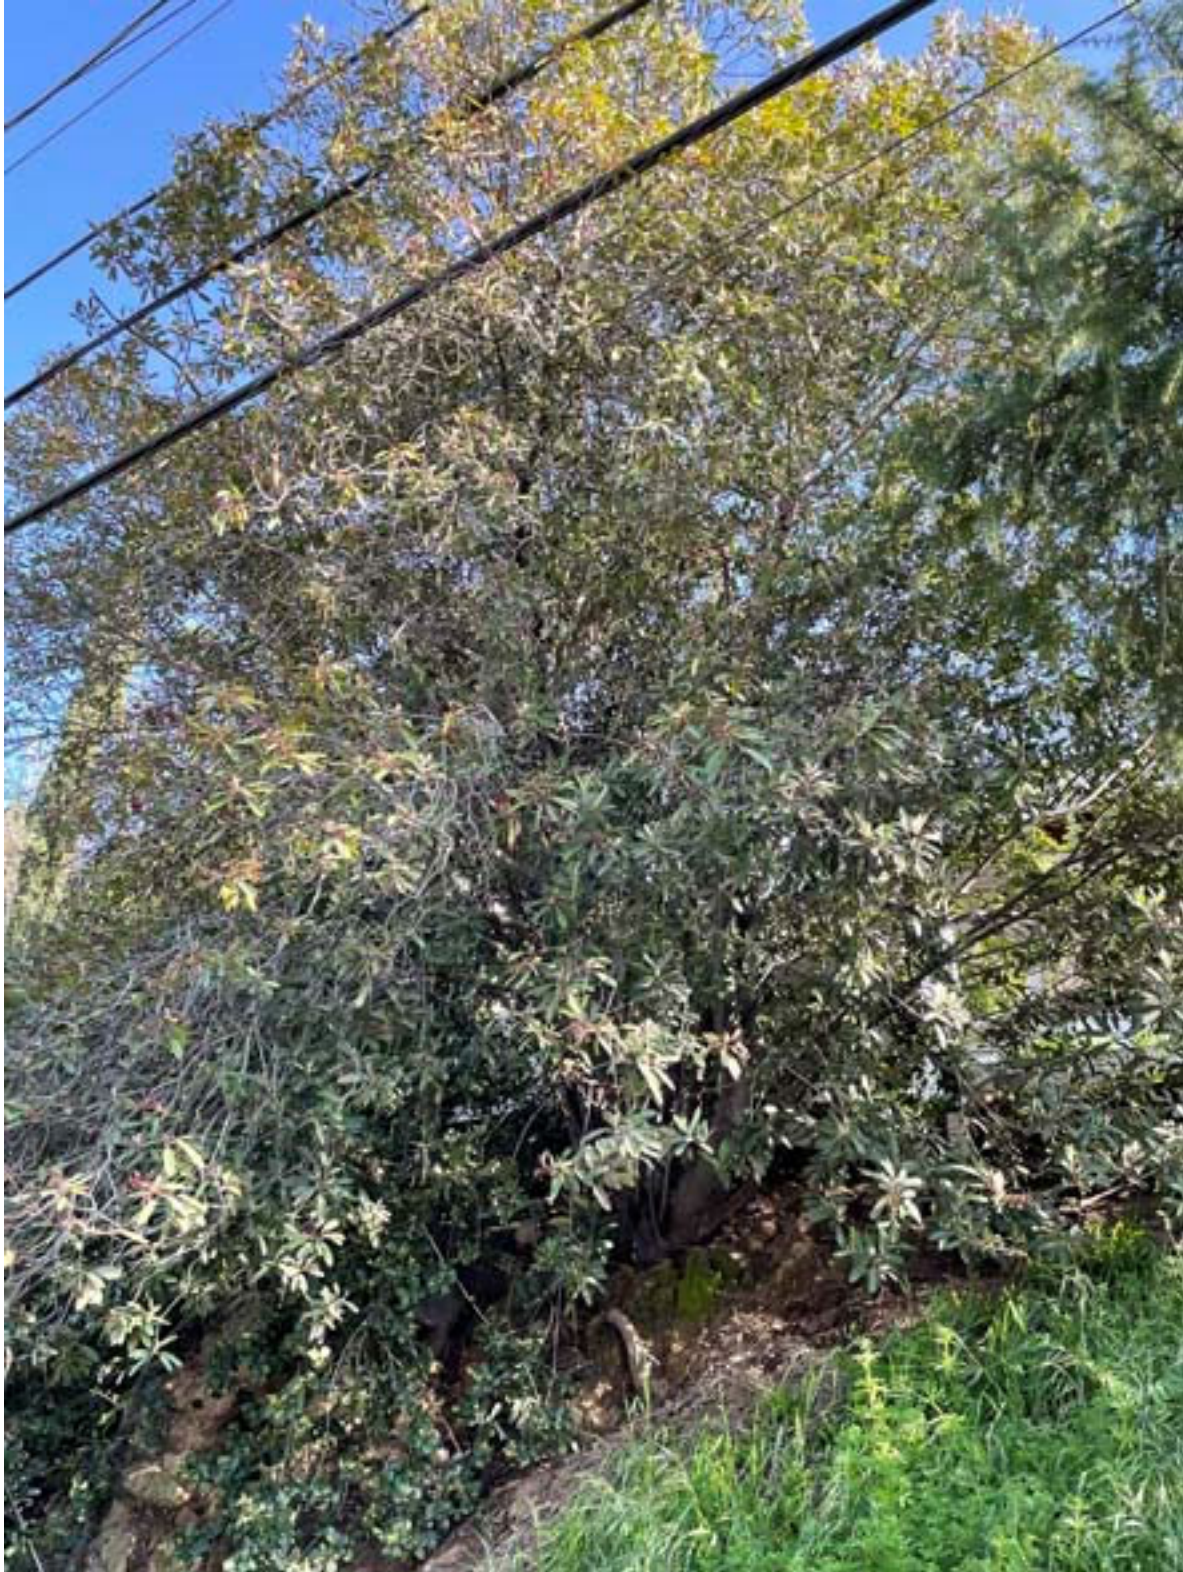
**Figure 10:** Tree 10

<p><b>Tree 10</b>  <i>Heteromeles arbutifolia</i> – Toyon</p> <p>This is a protected native tree per Ordinance 186,873. It will be retained in the landscape.</p> <p>This tree healthy. It is growing on a steep slope. I recommend contacting the utility company to alert them of the need to prune to establish minimum clearance.</p>

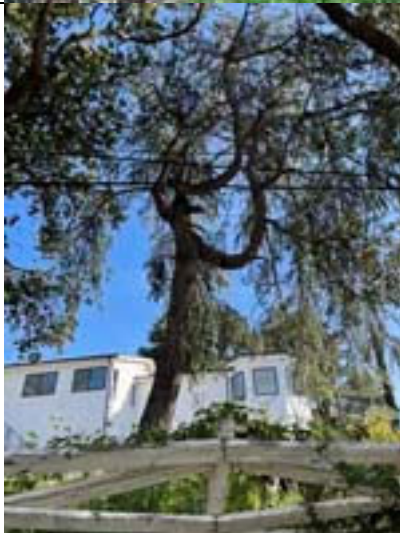
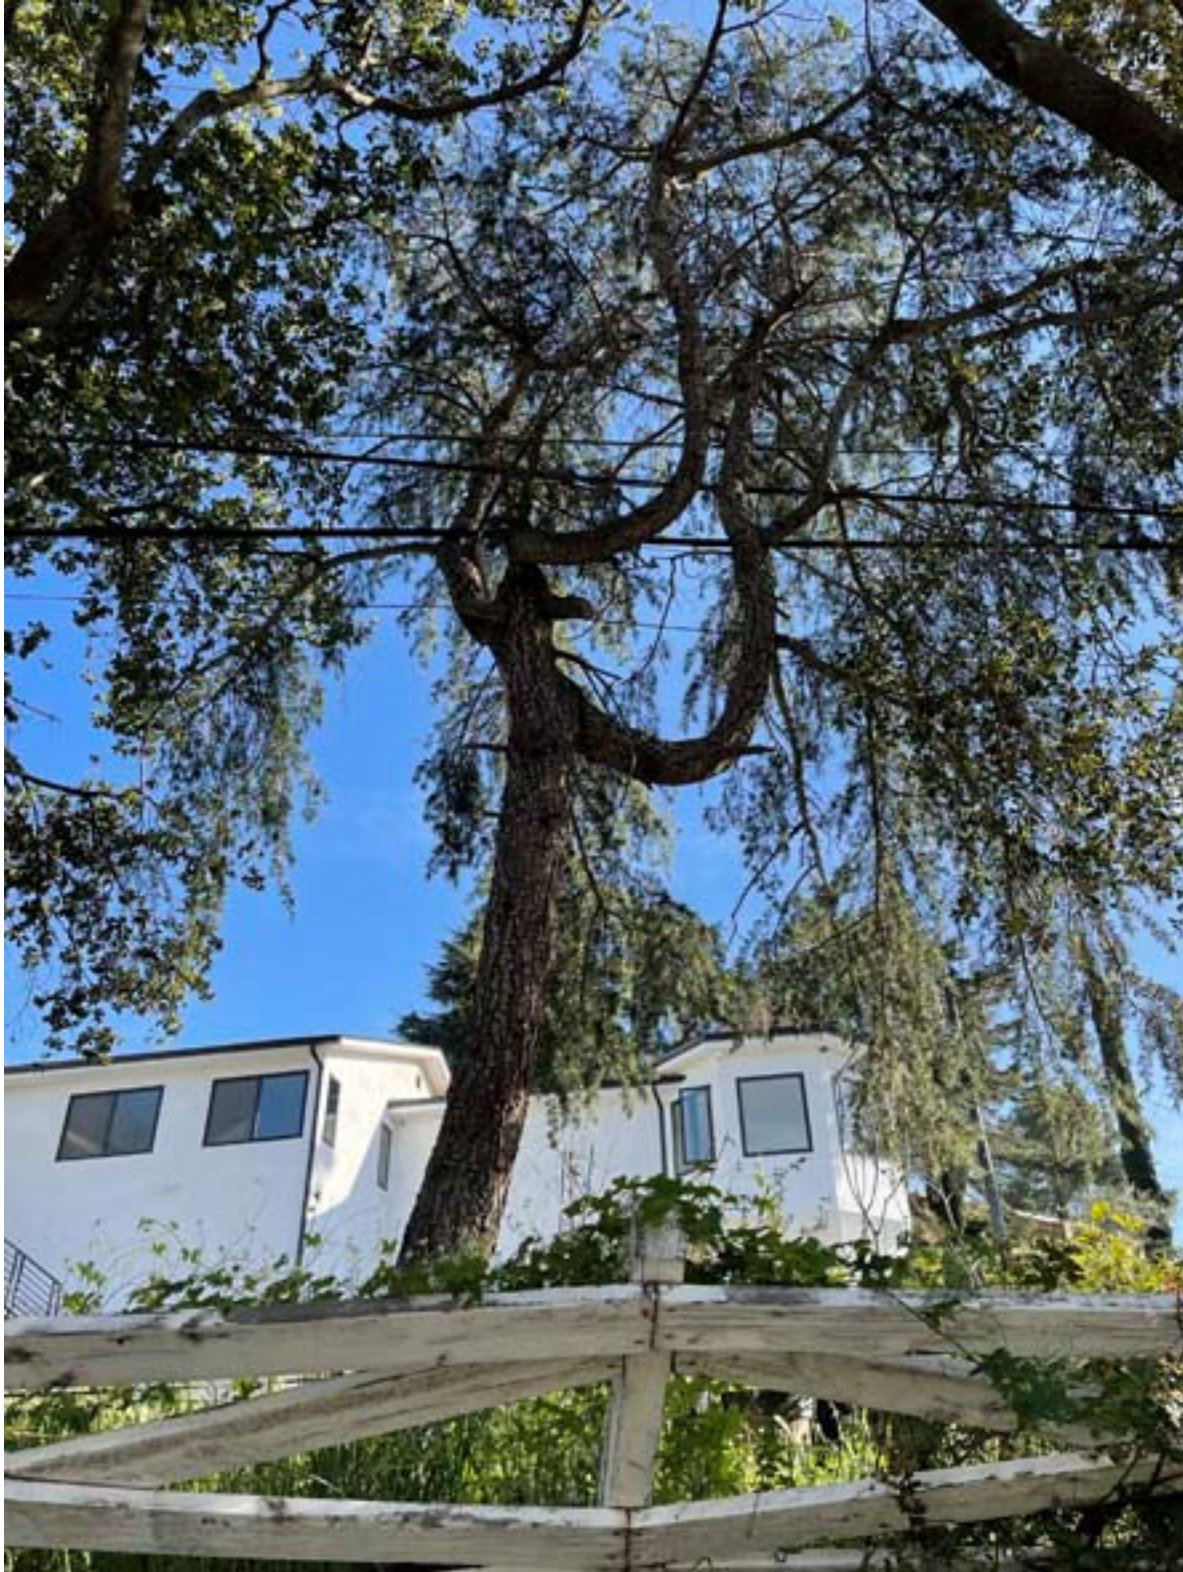
**Figure 11:** Tree 11

<p><b>Tree 11</b>  <i>Cedrus deodara</i> – Deodar Cedar</p> <p>This tree is not protected by ordinance. It will be retained in the landscape.</p> <p>This tree has a history of being pruned with topping cuts to establish line clearance. Despite its past care, this tree is still vigorous. Its upper branches are contacting the overhead utility lines. I recommend contacting the utility company to alert them of the need to prune to establish minimum clearance.</p>

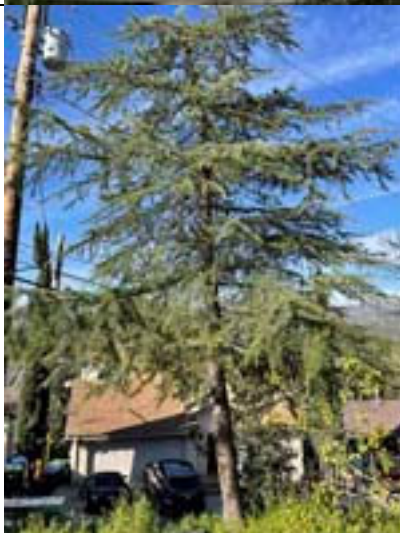
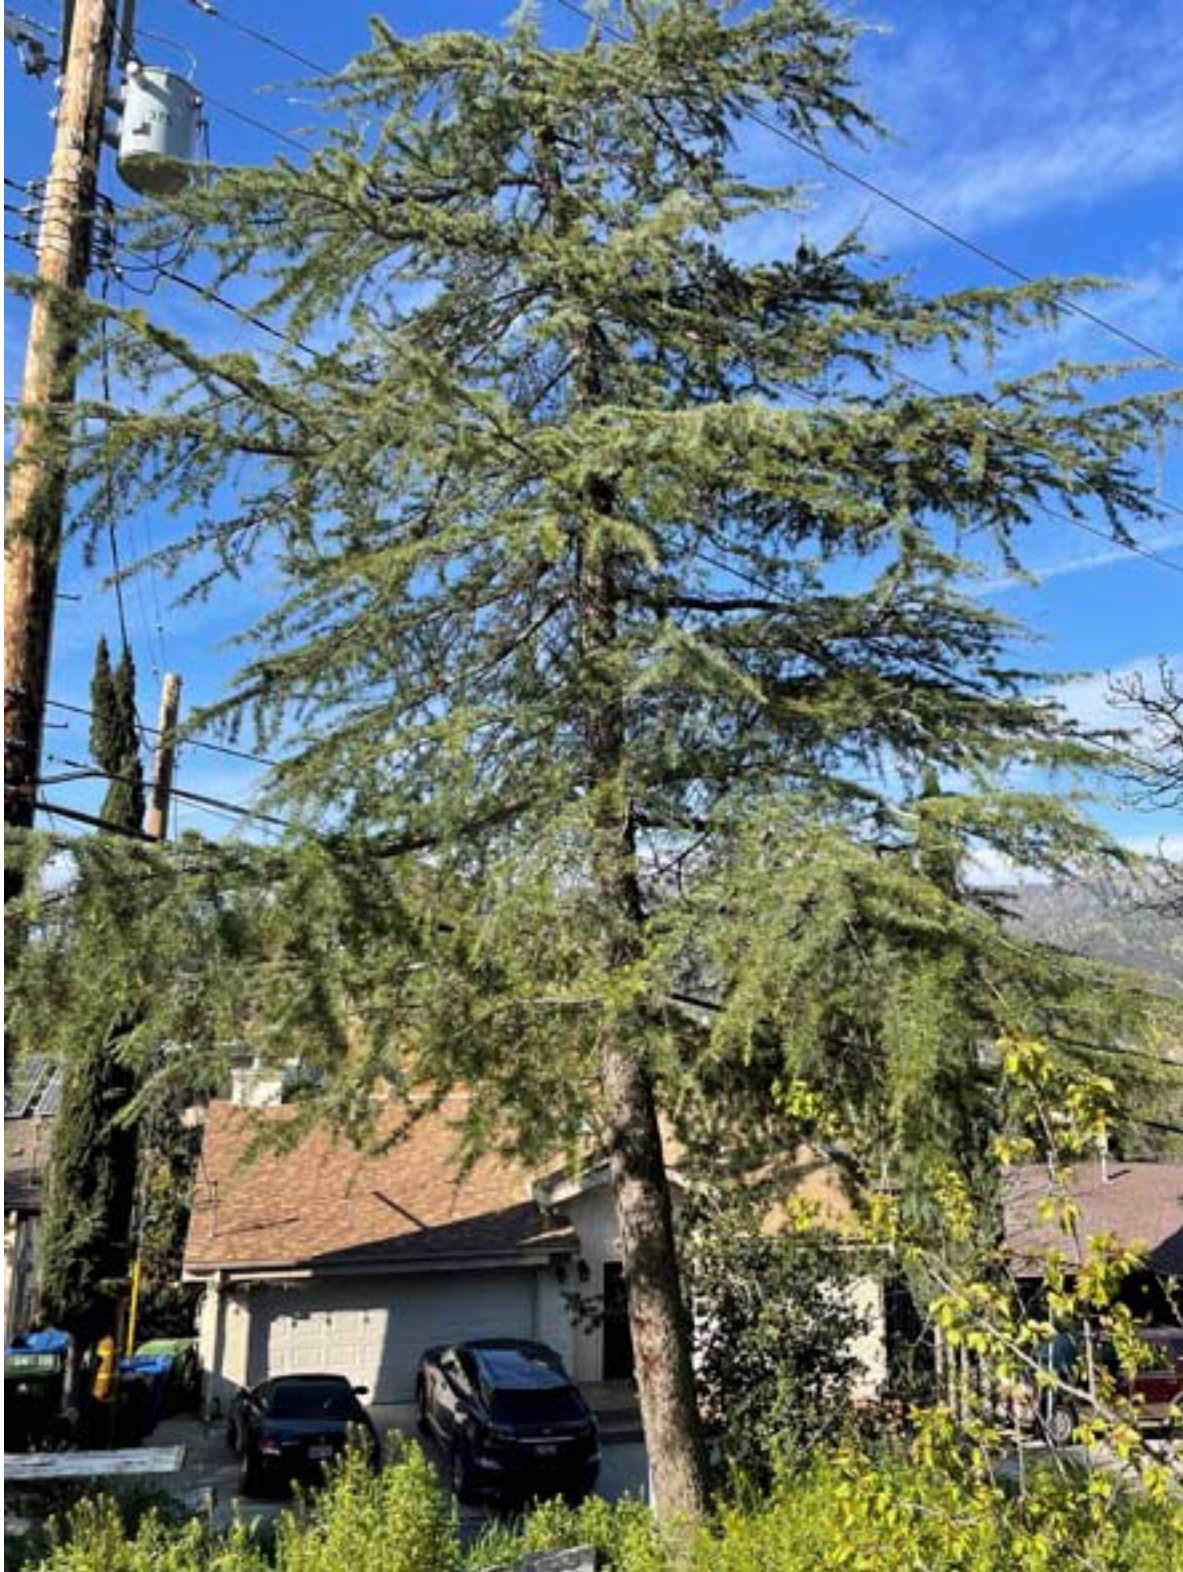
**Figure 12:** Tree 12

<p><b>Tree 12</b>  <i>Cedrus deodara</i> – Deodar Cedar</p> <p>This tree is not protected by ordinance. It will be retained in the landscape.</p> <p>This tree has symptoms of heat and drought stress. No treatment is recommended at this time.</p>

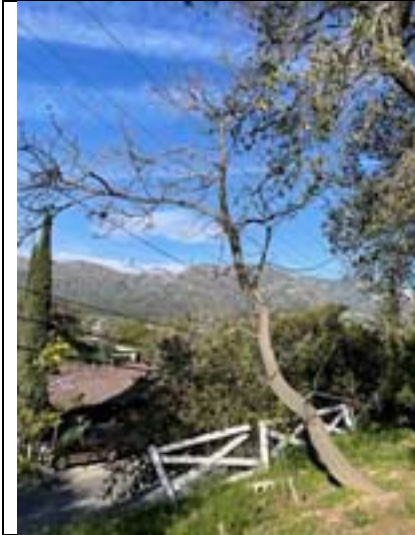
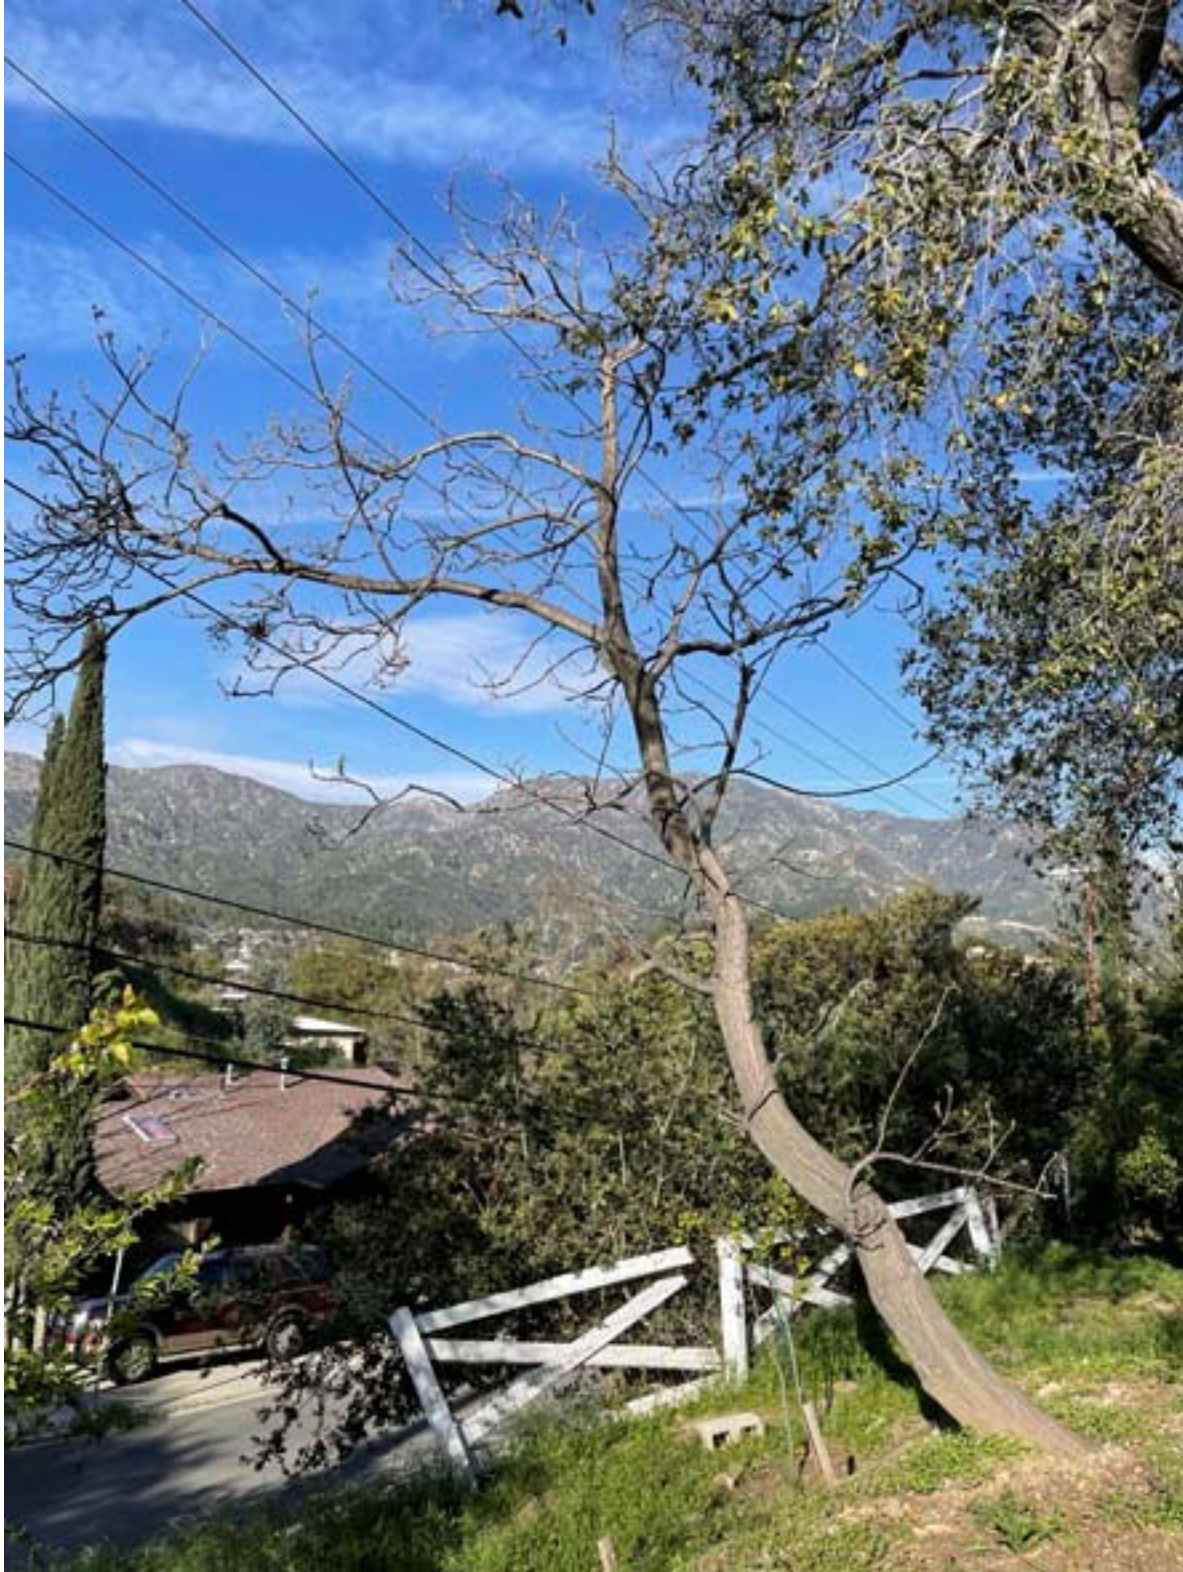
**Figure 13:** Tree 13

This tree is leaning, but it appears to be vigorous. I inspected this tree during its dormancy. No treatment is recommended at this time.
