# 9604 Hillhaven Ave. Arborist Report

Prepared for SEC Development  
c/o Vardan Kasemyan

**Prepared by James Komen**  
BCMA WE-9909B  
RCA #555

April 14, 2023

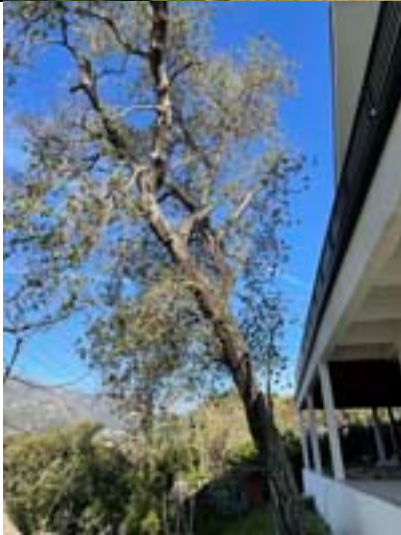
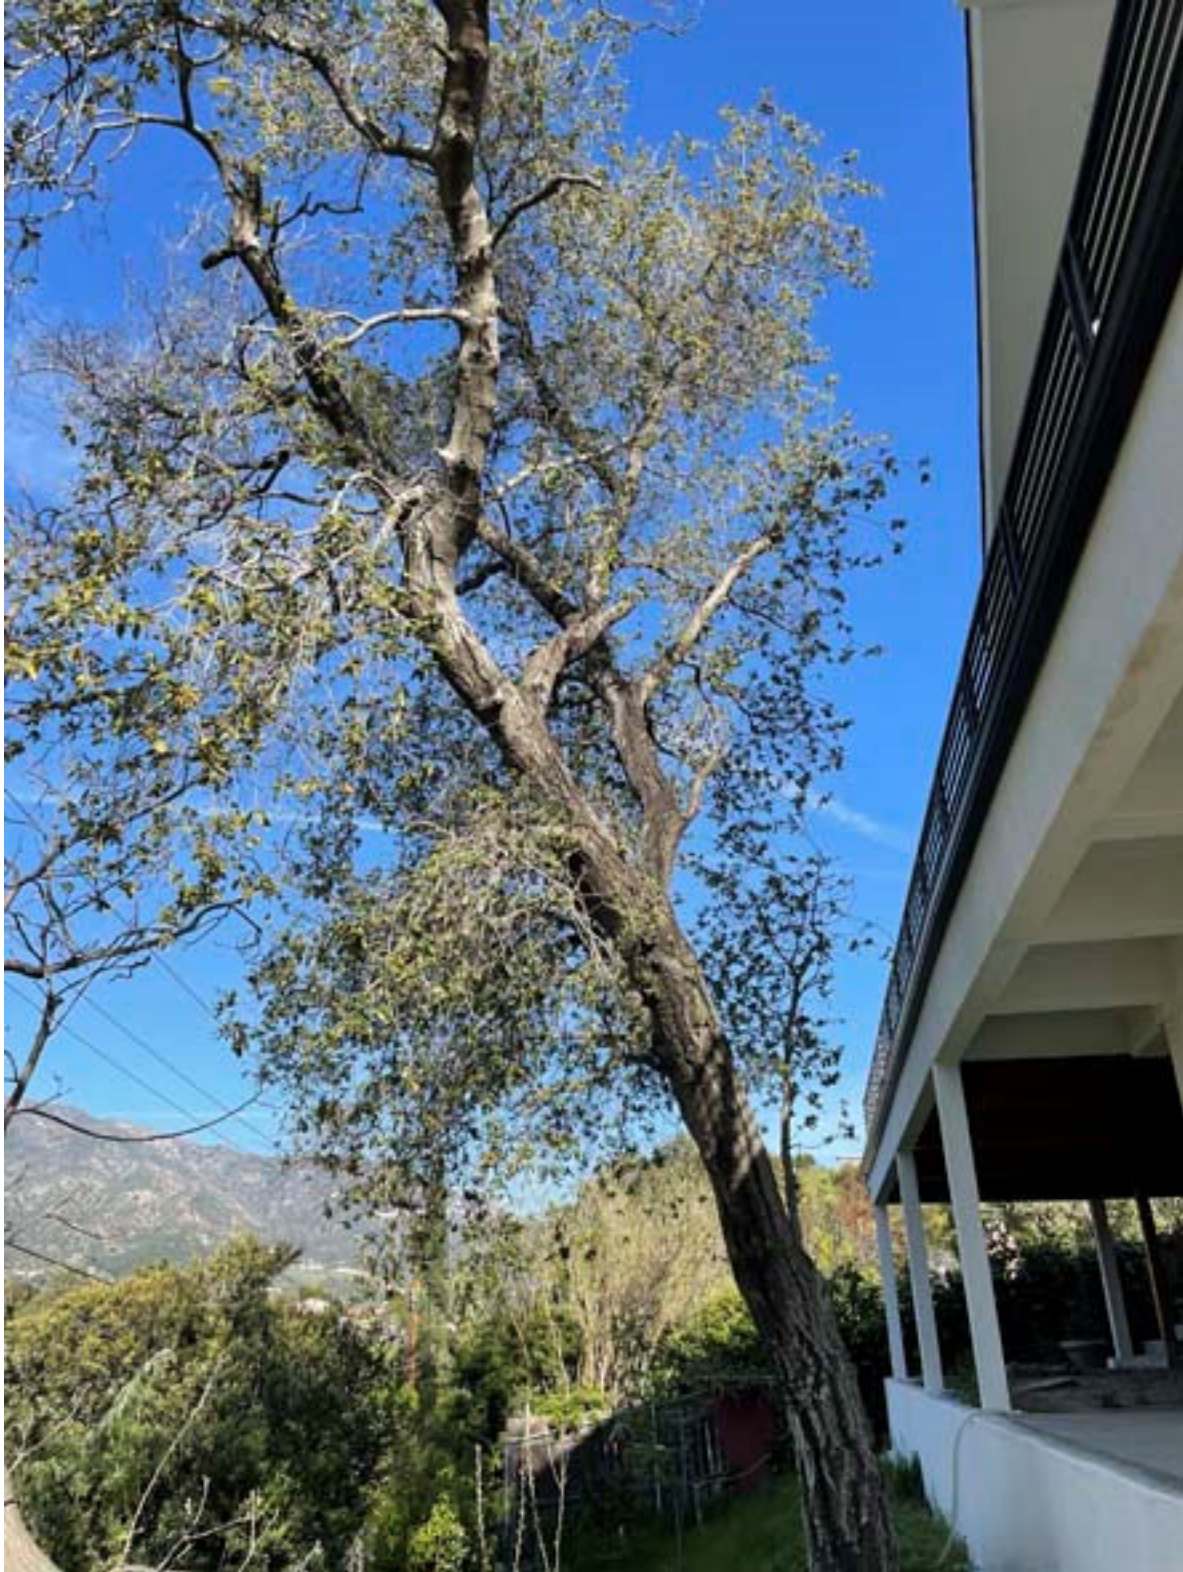
**Figure 14:** Tree 14

The toyon and 5 of the oaks are growing along the northern property line away from the work area, and they were not impacted. One oak tree next to the house is alive, but it has symptoms of decline. However, the work performed near this tree was all surface treatment, and no excavation was involved. It is possible that this tree is declining for reasons other than construction impacts. I was unable to conclusively determine the cause of the tree's decline.

This tree is stressed. I was unable to determine the cause of its decline at the time of my site visit. It is possible that it was related to heat, drought, or root rot pathogens that were not observable at the time of my site visit.

I was informed that within the past 6 years, there has been no substantial digging within the drip line of this tree. The adjacent walkway was resurfaced, and new stucco was applied to the wall, but both activities were surface treatments that would not likely impact the roots.

- Construction is already complete, so no pre-construction or during-construction recommendations are applicable.
- Fencing:
  - If the city requires tree protection fencing as a ministerial requirement for processing this report, then erect snow fencing as shown in the site plan around Tree 14. Fencing should be in-ground, free standing, at least 4 feet in height, and brightly colored.

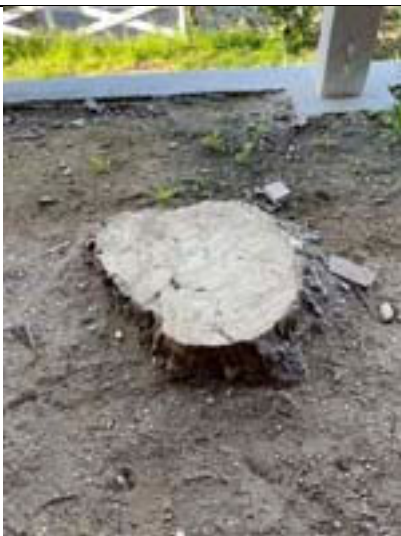
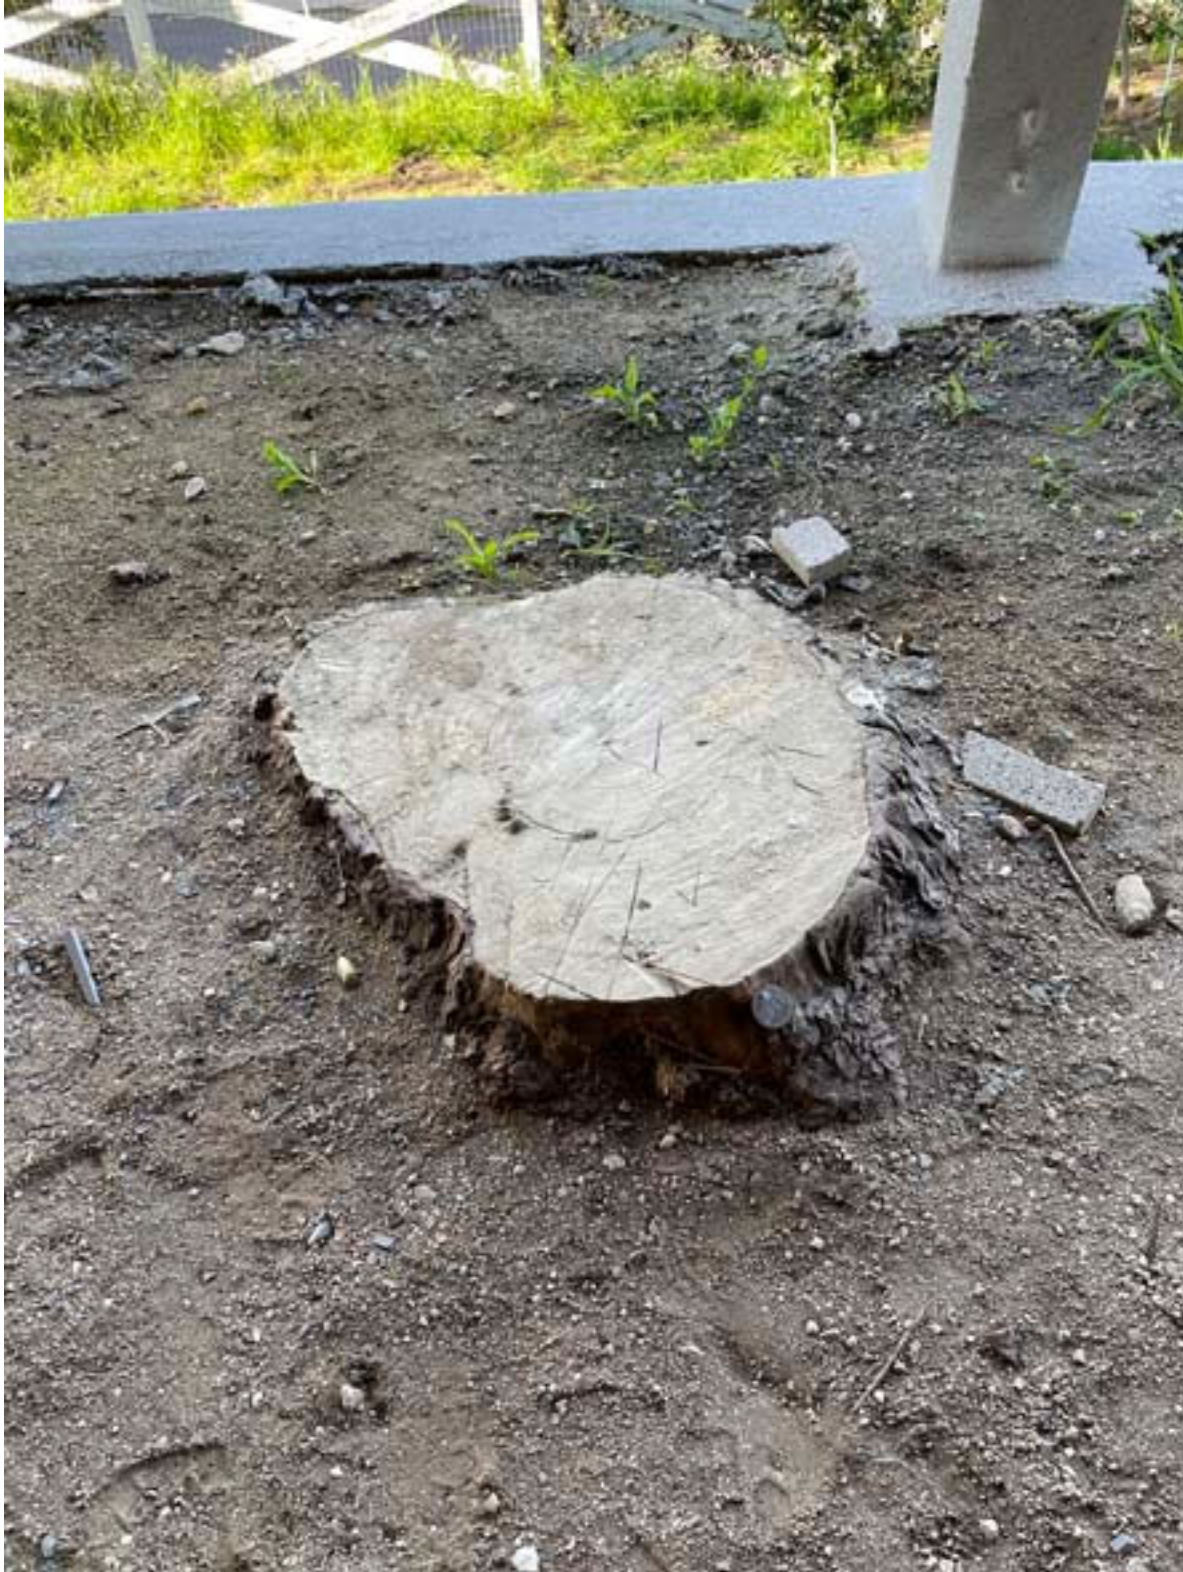
**Figure 15:** Tree 15

This tree is not protected by ordinance. It is a dead stump of a tree that was cut down in 2020.

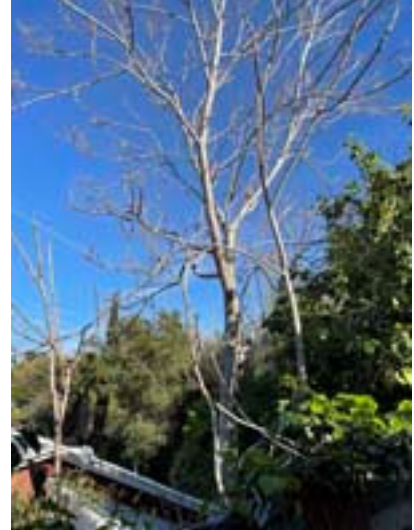
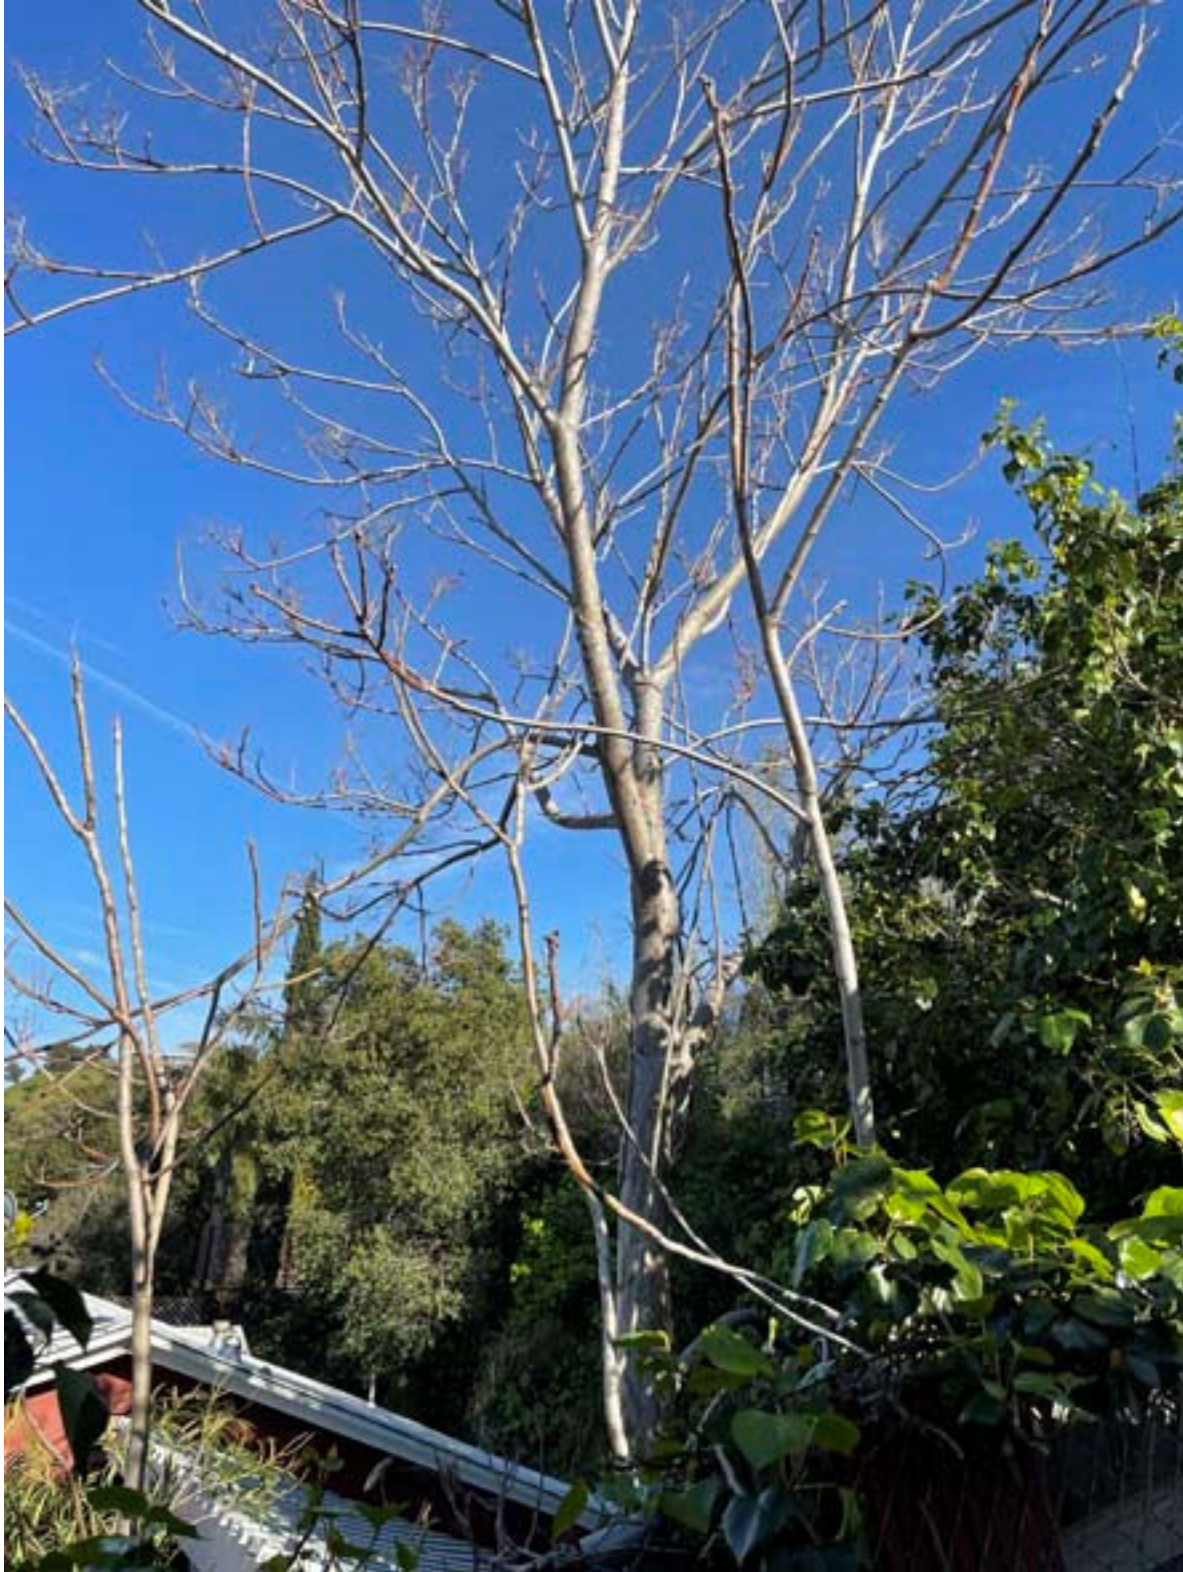
**Figure 16:** Tree OP16

<p><b>Tree OP16</b>  <i>Ailanthus altissima</i> – Tree of Heaven</p> <p>This tree is a prohibited species per Ordinance 175,736, the San Gabriel/Verdugo Mountains Scenic Preservation Plan. It is growing on an adjacent property to the east. It will be retained in the landscape.</p> <p>This tree is healthy.</p>

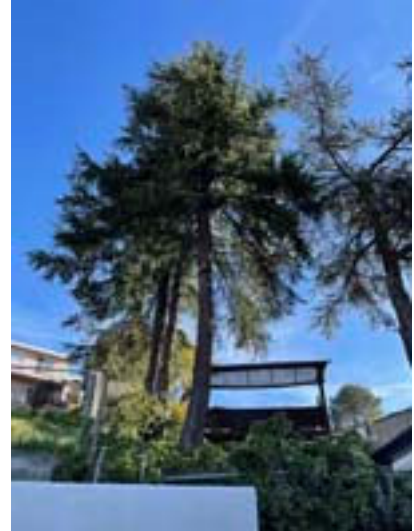
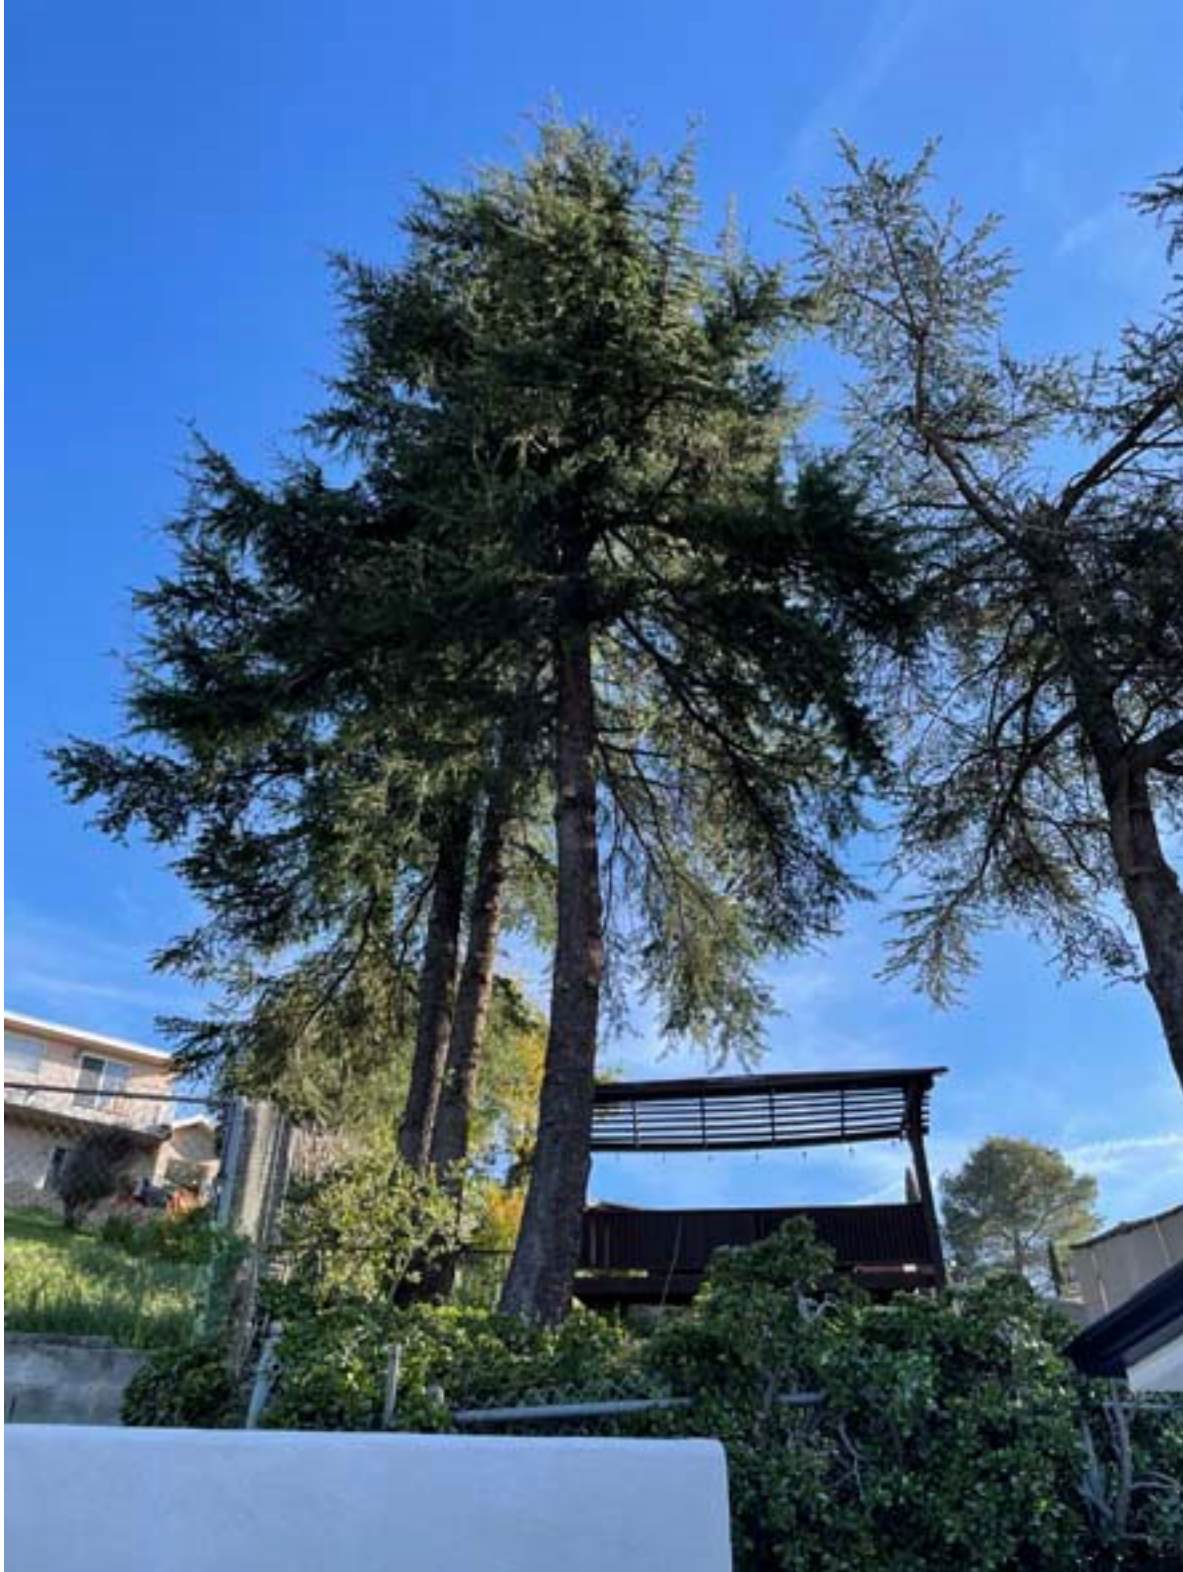
**Figure 17:** Tree OP17

<p><b>Tree OP17</b>  <i>Cedrus deodara</i> – Deodar Cedar</p> <p>This tree is not protected by ordinance. It is growing on an adjacent property to the south. It will be retained in the landscape.</p> <p>This tree is healthy. Its lower branches have been pruned off, leaving most of its canopy suspended above a bare trunk. No treatment is recommended at this time.</p>

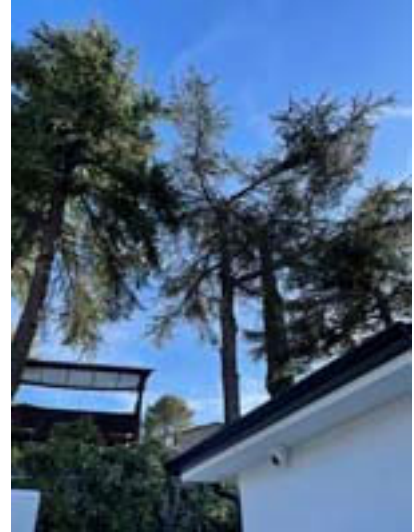
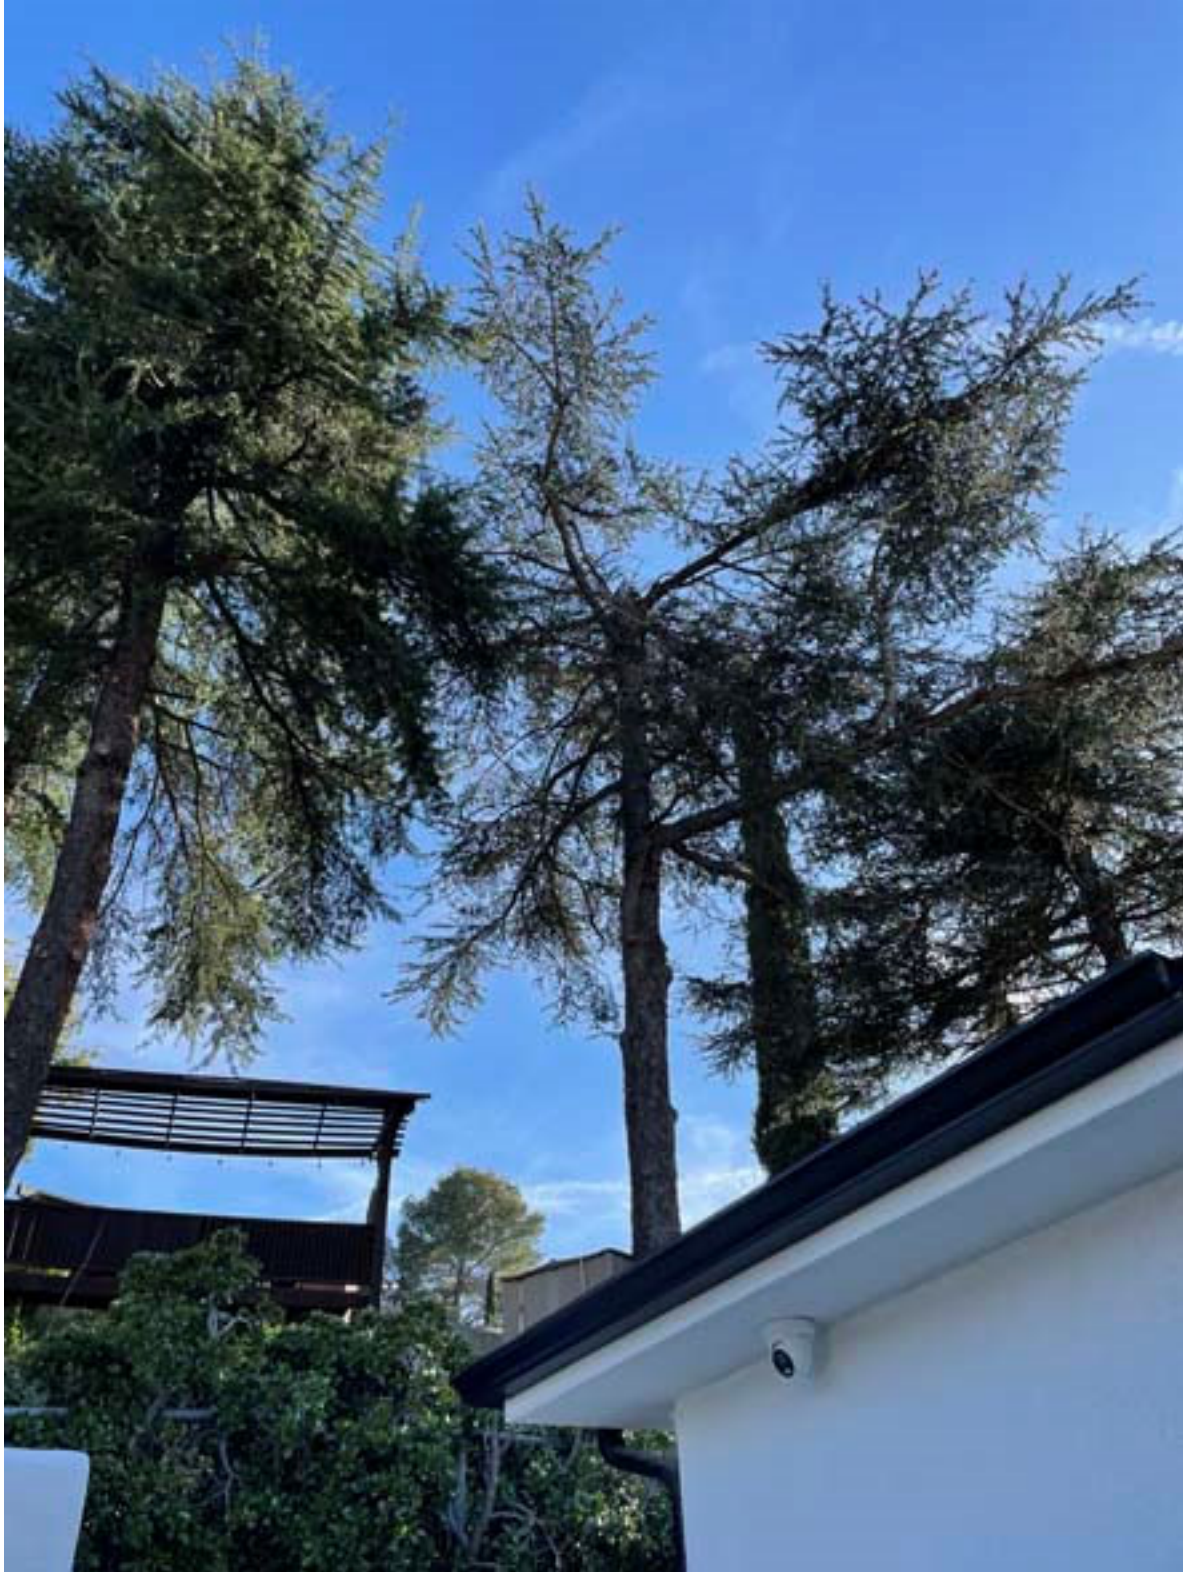
**Figure 18:** Tree OP18

<p><b>Tree OP18</b>  <i>Cedrus deodara</i> – Deodar Cedar</p> <p>This tree is not protected by ordinance. It is growing on an adjacent property to the south. It will be retained in the landscape.</p> <p>The top of this tree tore out in a storm several years ago. The remaining tree is stressed, and I observed a decline in vigor in the foliage. No treatment is recommended at this time.</p> <p>Construction access for the additions passed within the drip line of this tree, but the access route did not likely affect this tree because this tree is separated from the route by a retaining wall, and the access route passed over existing hardscape that remained in place.</p>

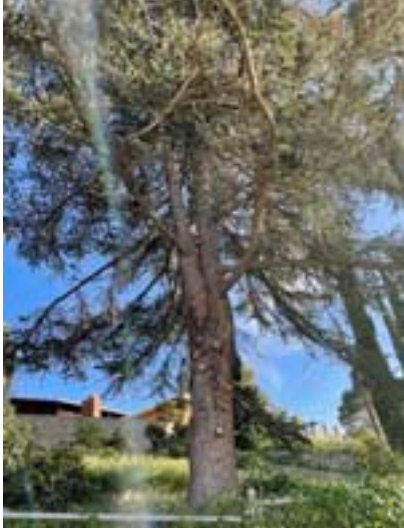
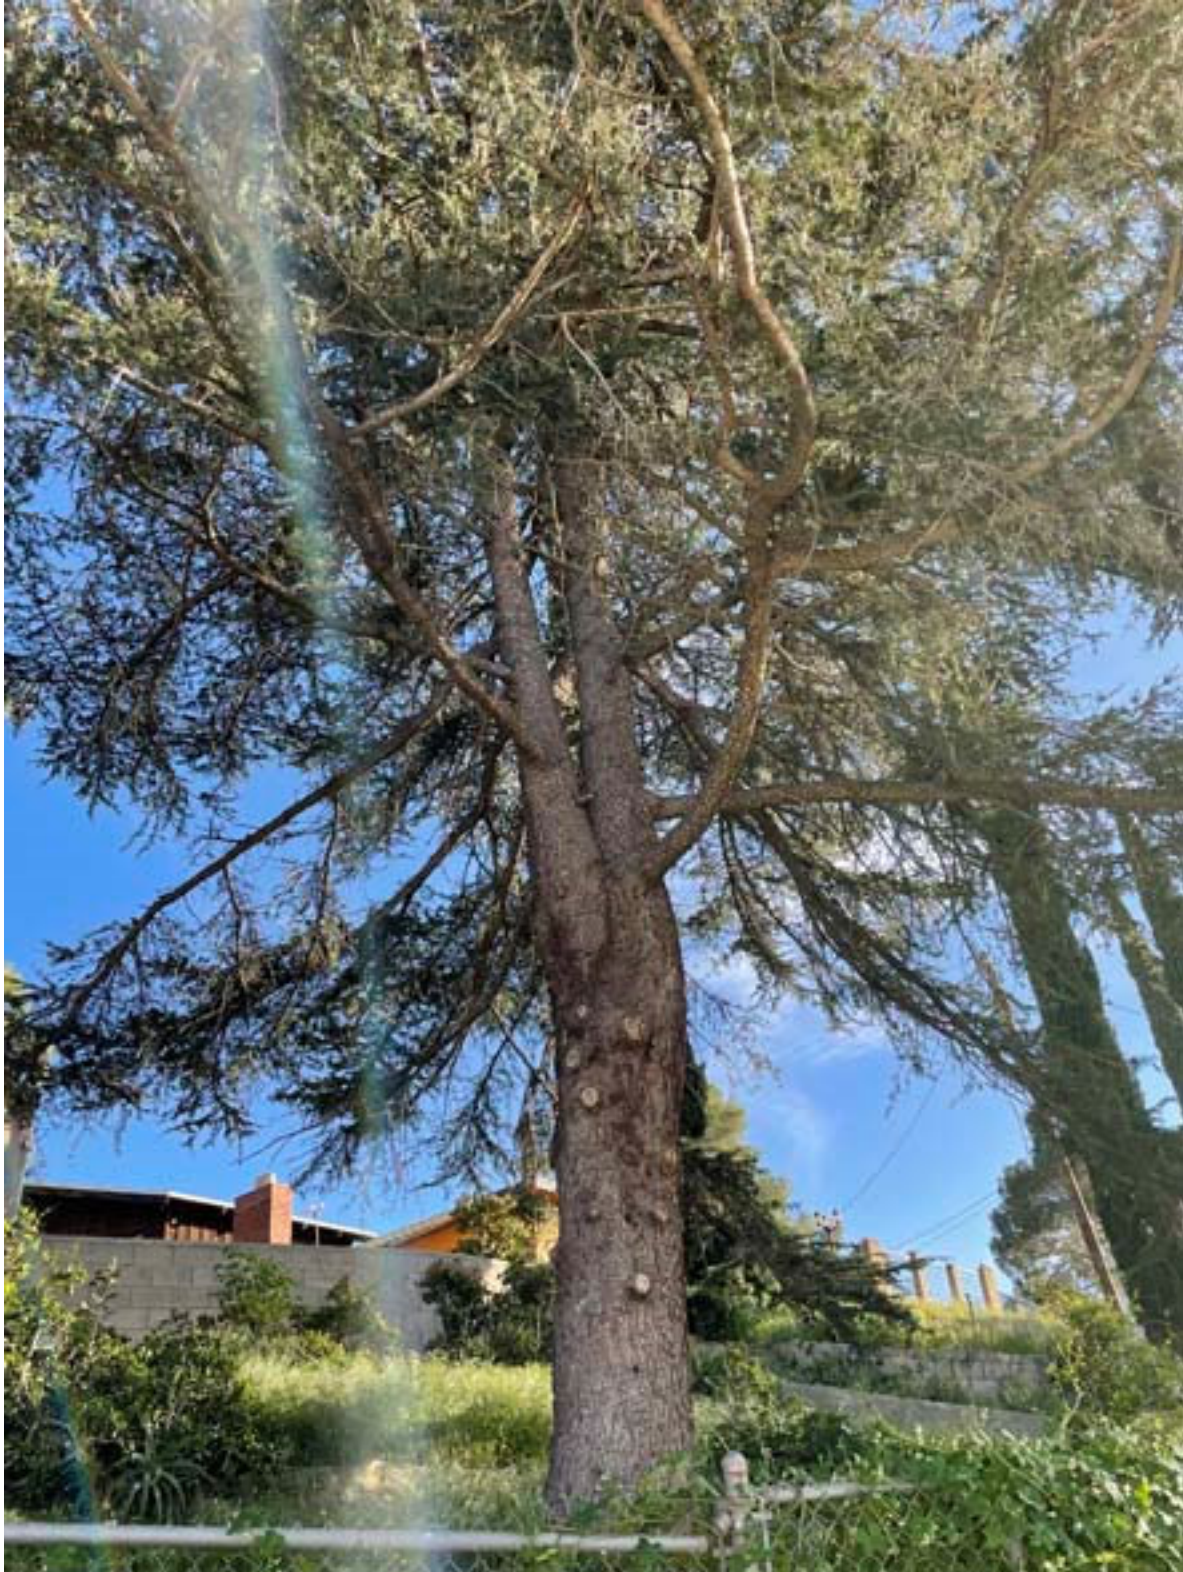
**Figure 19:** Tree OP19

<p><b>Tree OP19</b>  <i>Cedrus deodara</i> – Deodar Cedar</p> <p>This tree is not protected by ordinance. It is growing on an adjacent property to the south. It will be retained in the landscape.</p> <p>This tree has co-dominant stems. It is vigorous. No treatment is recommended at this time.</p> <p>Construction access for the additions passed within the drip line of this tree, but the access route did not likely affect this tree because this tree is separated from the route by a retaining wall, and the access route passed over existing hardscape that remained in place.</p>

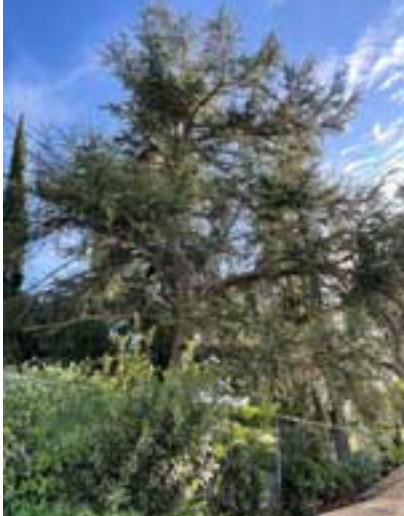
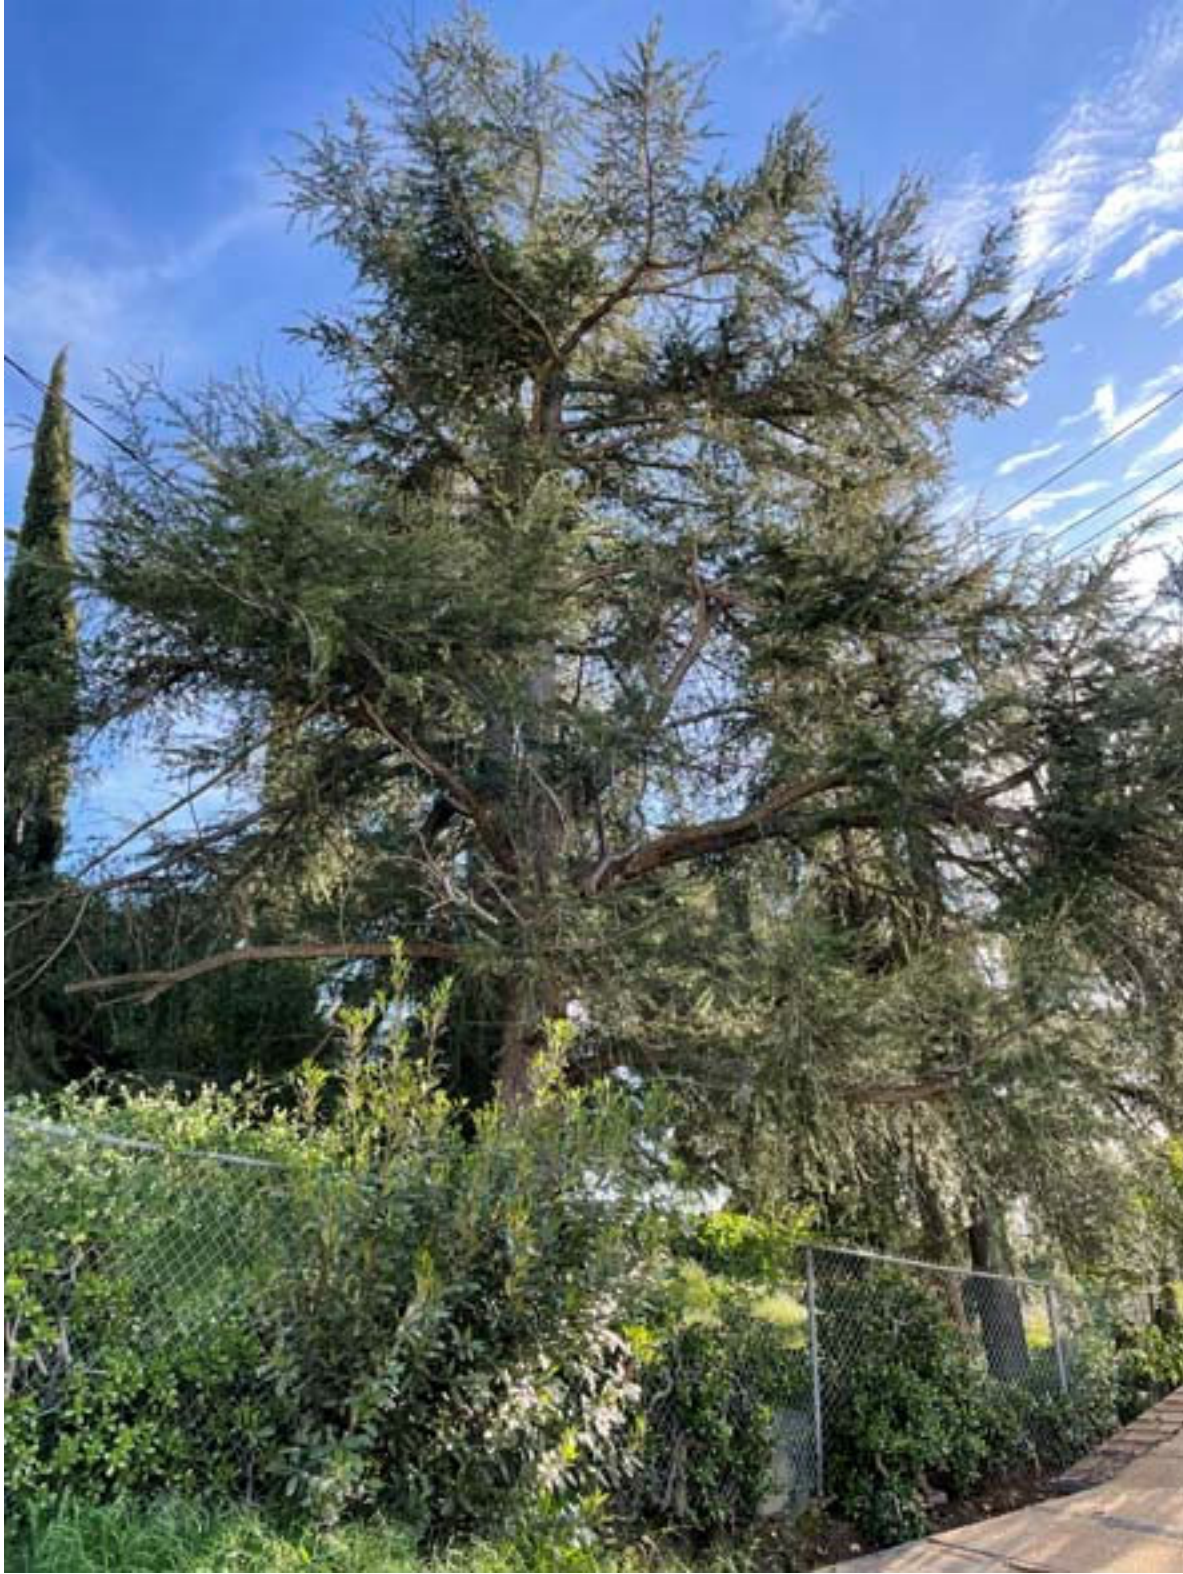
**Figure 20:** Tree OP20

<p><b>Tree OP20</b>  <i>Cedrus deodara</i> – Deodar Cedar</p> <p>This tree is not protected by ordinance. It is growing on an adjacent property to the south. It will be retained in the landscape.</p> <p>This tree is healthy. No treatment is recommended at this time.</p>

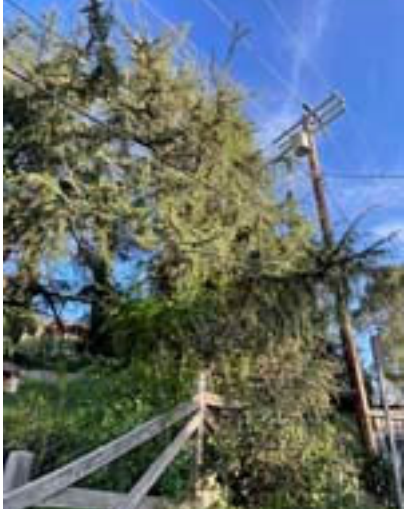
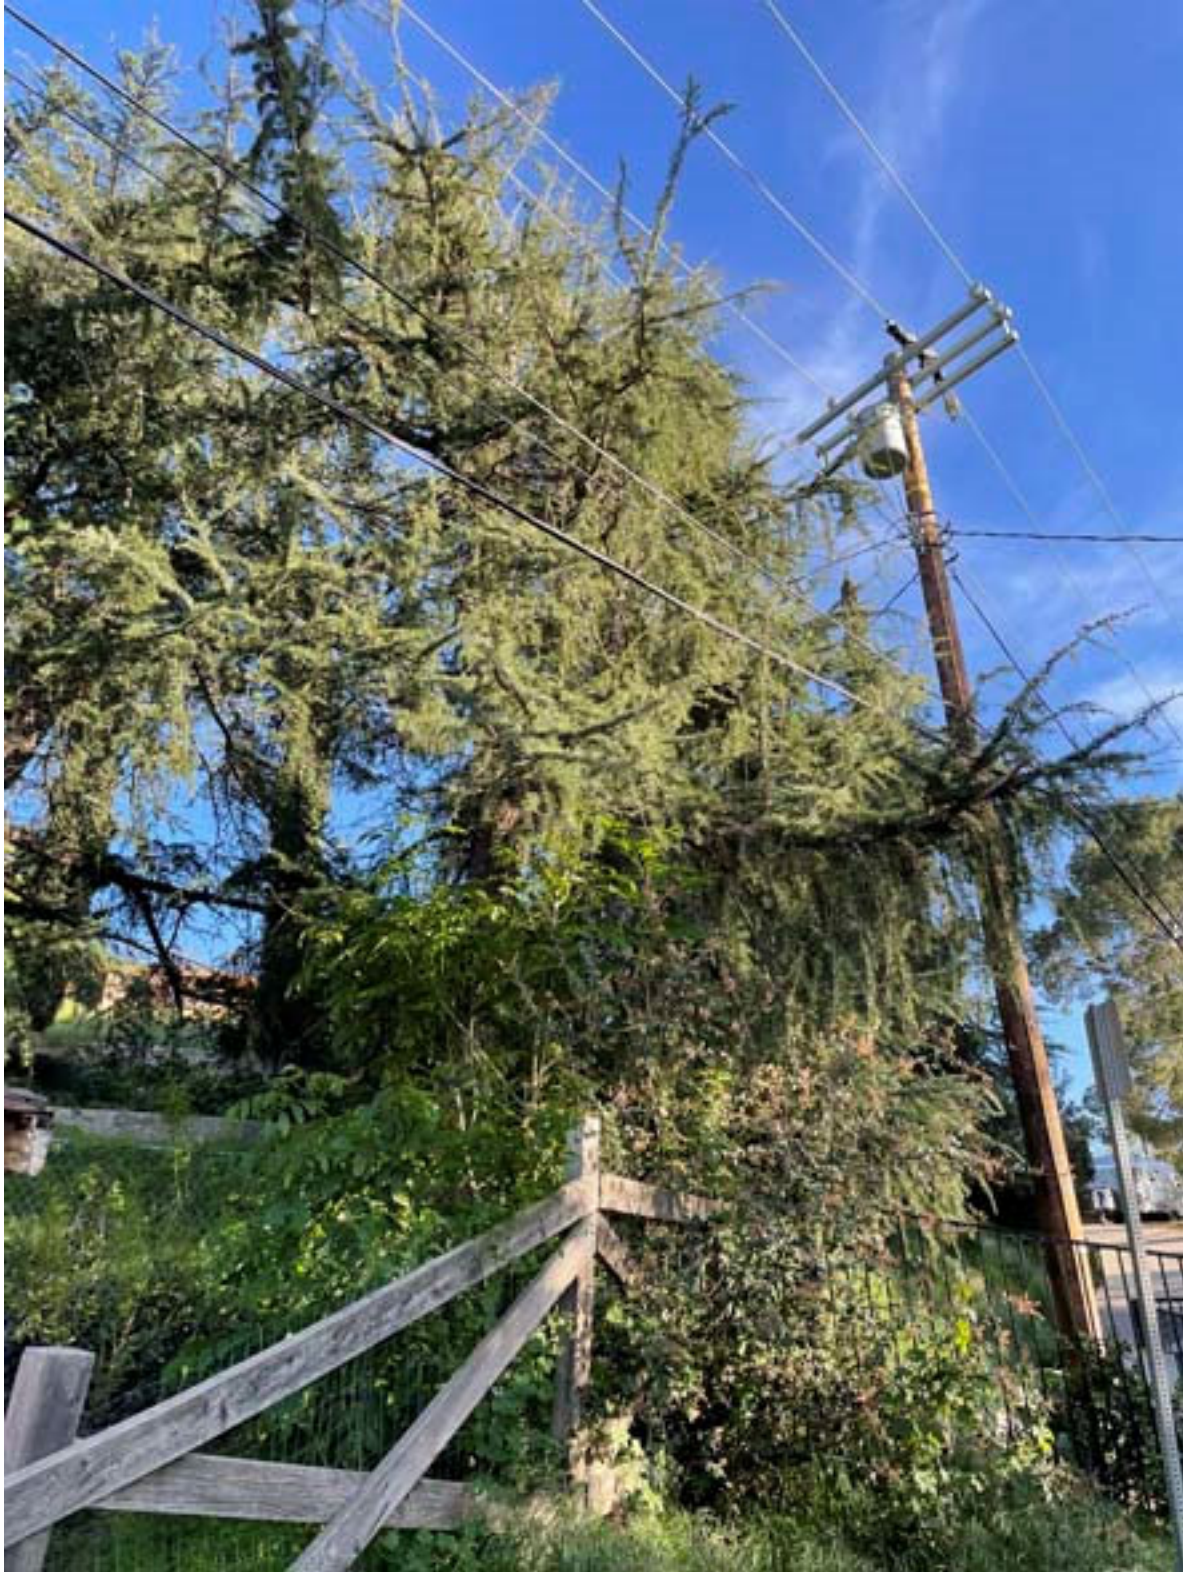
**Figure 21:** Tree OP21

<p><b>Tree OP21</b>  <i>Cedrus deodara</i> – Deodar Cedar</p> <p>This tree is not protected by ordinance. It is growing on an adjacent property to the south. It will be retained in the landscape.</p> <p>This tree is healthy. No treatment is recommended at this time.</p>

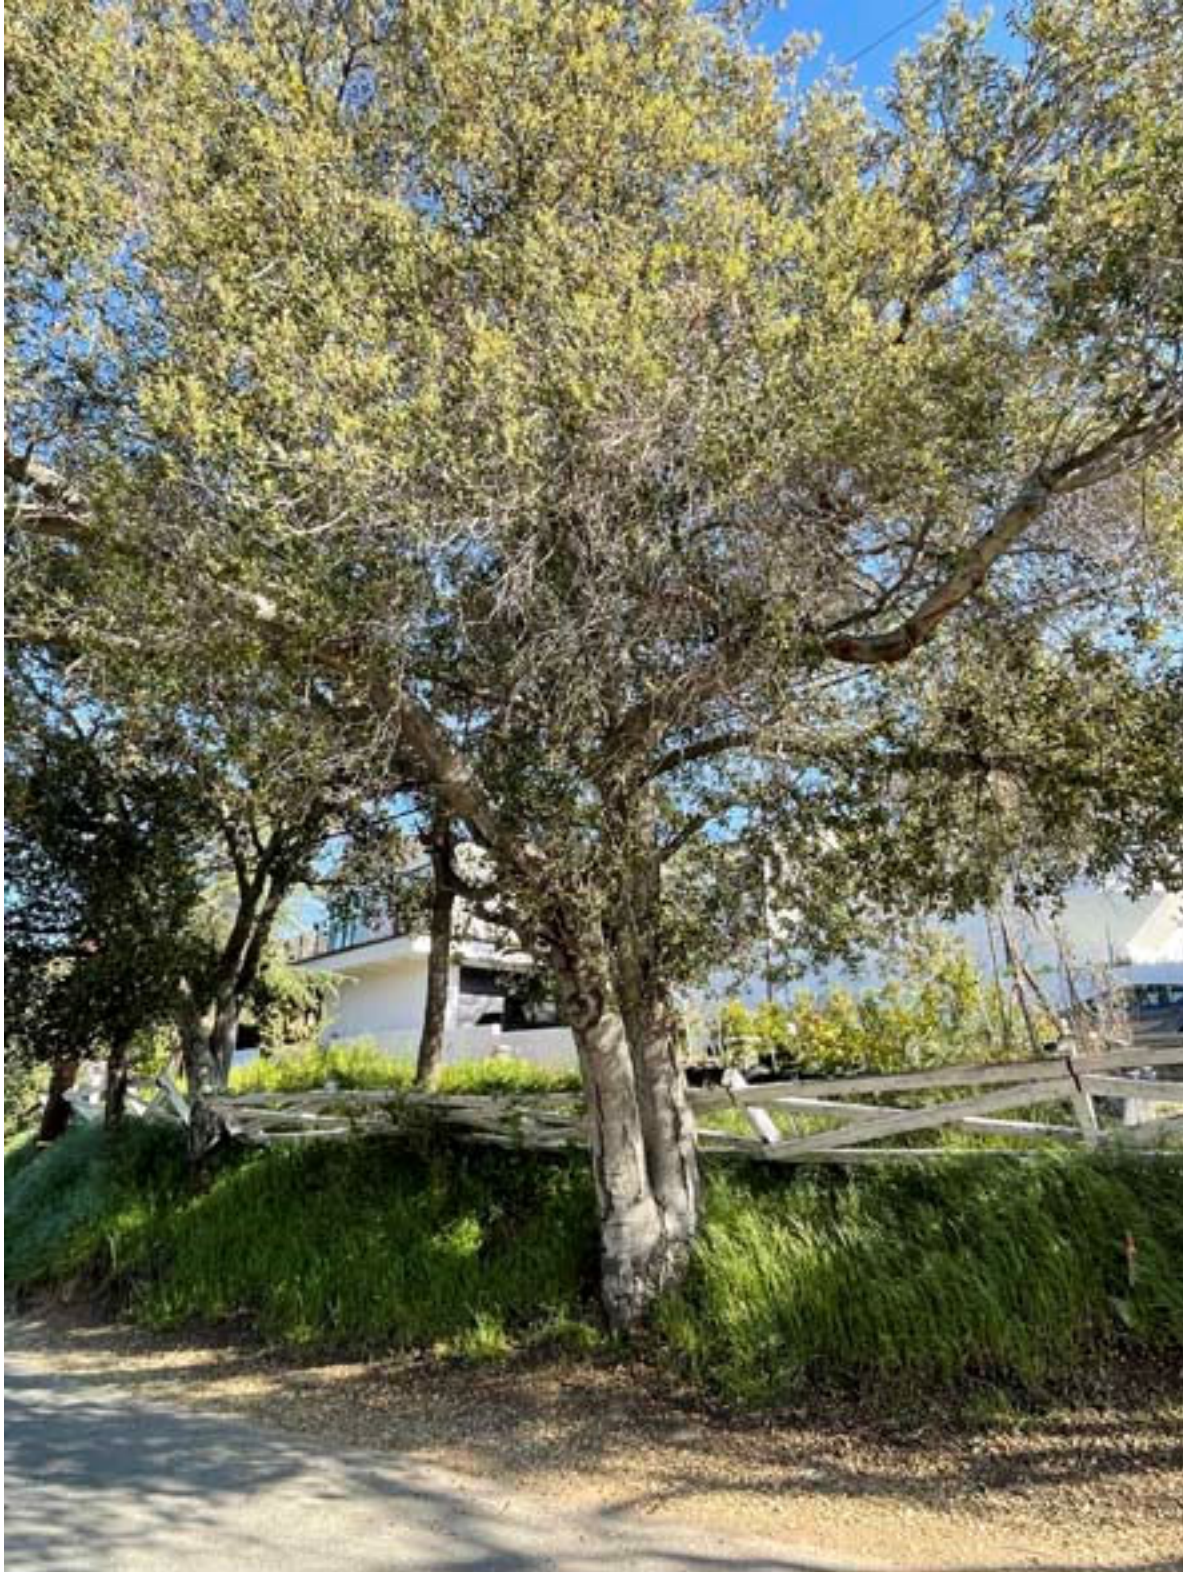
**Figure 4:** Tree 4

<p><b>Tree 4</b>  <i>Quercus agrifolia</i> – Coast Live Oak</p> <p>This is a protected native tree per Ordinance 186,873. It will be retained in the landscape.</p> <p>This tree has co-dominant stems. Its foliage has symptoms of heat and drought stress. Its upper branches are contacting the overhead utility lines. I recommend contacting the utility company to alert them of the need to prune to establish minimum clearance.</p>
 	<p><b>Tree 5</b>  <i>Quercus agrifolia</i> – Coast Live Oak</p> <p>This is a protected native tree per Ordinance 186,873. It will be retained in the landscape.</p> <p>This tree has co-dominant stems. Its foliage has symptoms of heat and drought stress. Its upper branches are contacting the overhead utility lines. I recommend contacting the utility company to alert them of the need to prune to establish minimum clearance.</p>
 	<p><b>Tree 6</b>  <i>Quercus agrifolia</i> – Coast Live Oak</p> <p>This is a protected native tree per Ordinance 186,873. It will be retained in the landscape.</p> <p>This tree has been partially suppressed due to competition with its neighbors. Its upper branches are contacting the overhead utility lines. I recommend contacting the utility company to alert them of the need to prune to establish minimum clearance.</p>

- Removals:
  - The stump of Tree 15 may be removed, or it may be allowed to decompose into the ground.
- Pruning:
  - Inform the utility company that Trees 3-6 and 9-11 are in contact with the low-voltage utility lines and that clearance pruning is recommended. Only a qualified line clearance tree trimmer may prune trees within 10 feet of the lines.

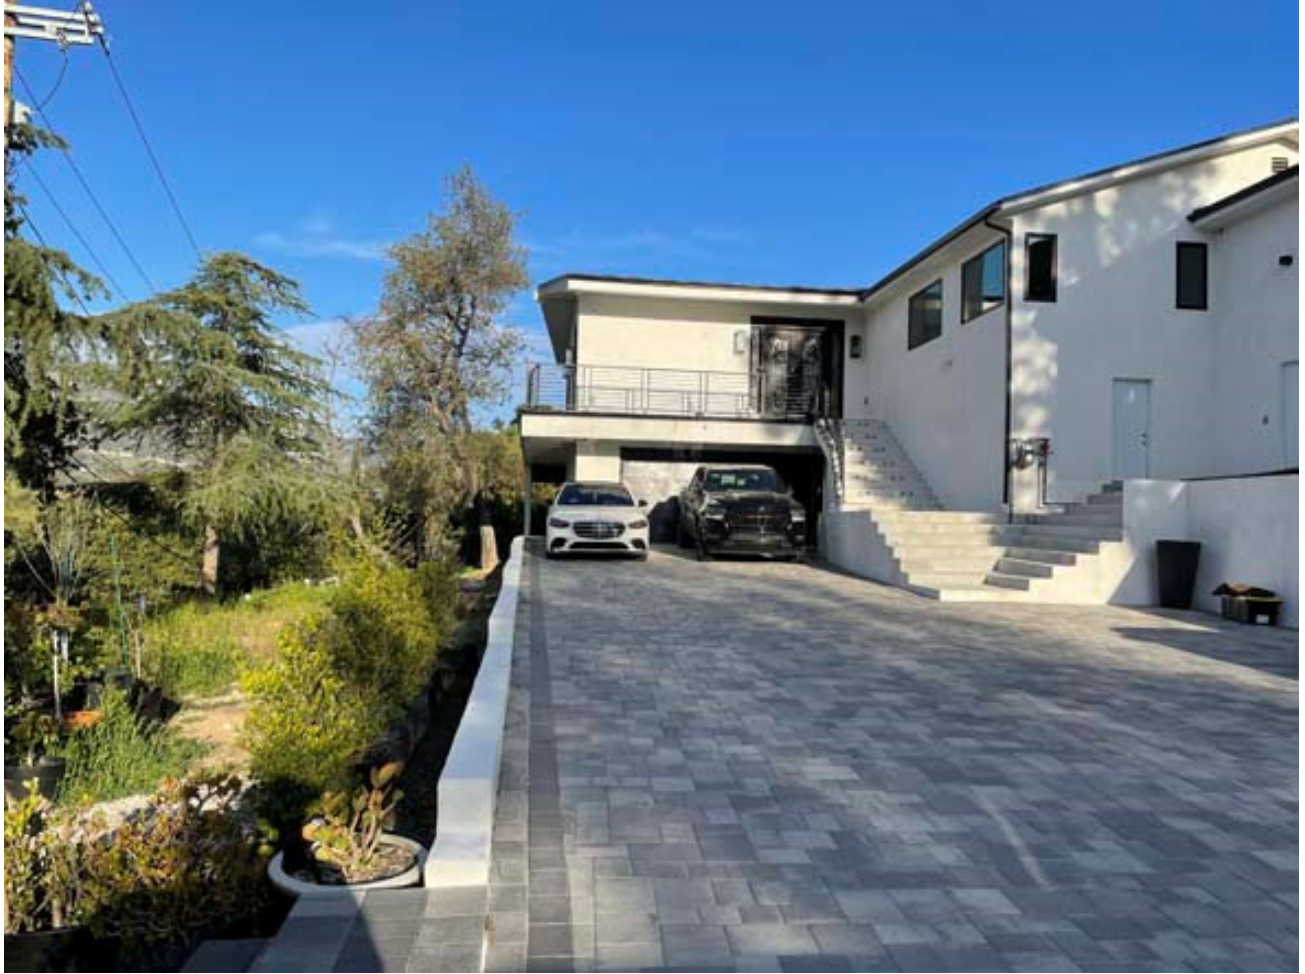
**Figure 23:** Looking east along the resurfaced driveway. Tree 14 is seen next to the house in the background.
