# 9604 Hillhaven Ave. Arborist Report

Prepared for SEC Development  
c/o Vardan Kasemyan

**Prepared by James Komen**  
BCMA WE-9909B  
RCA #555

April 14, 2023

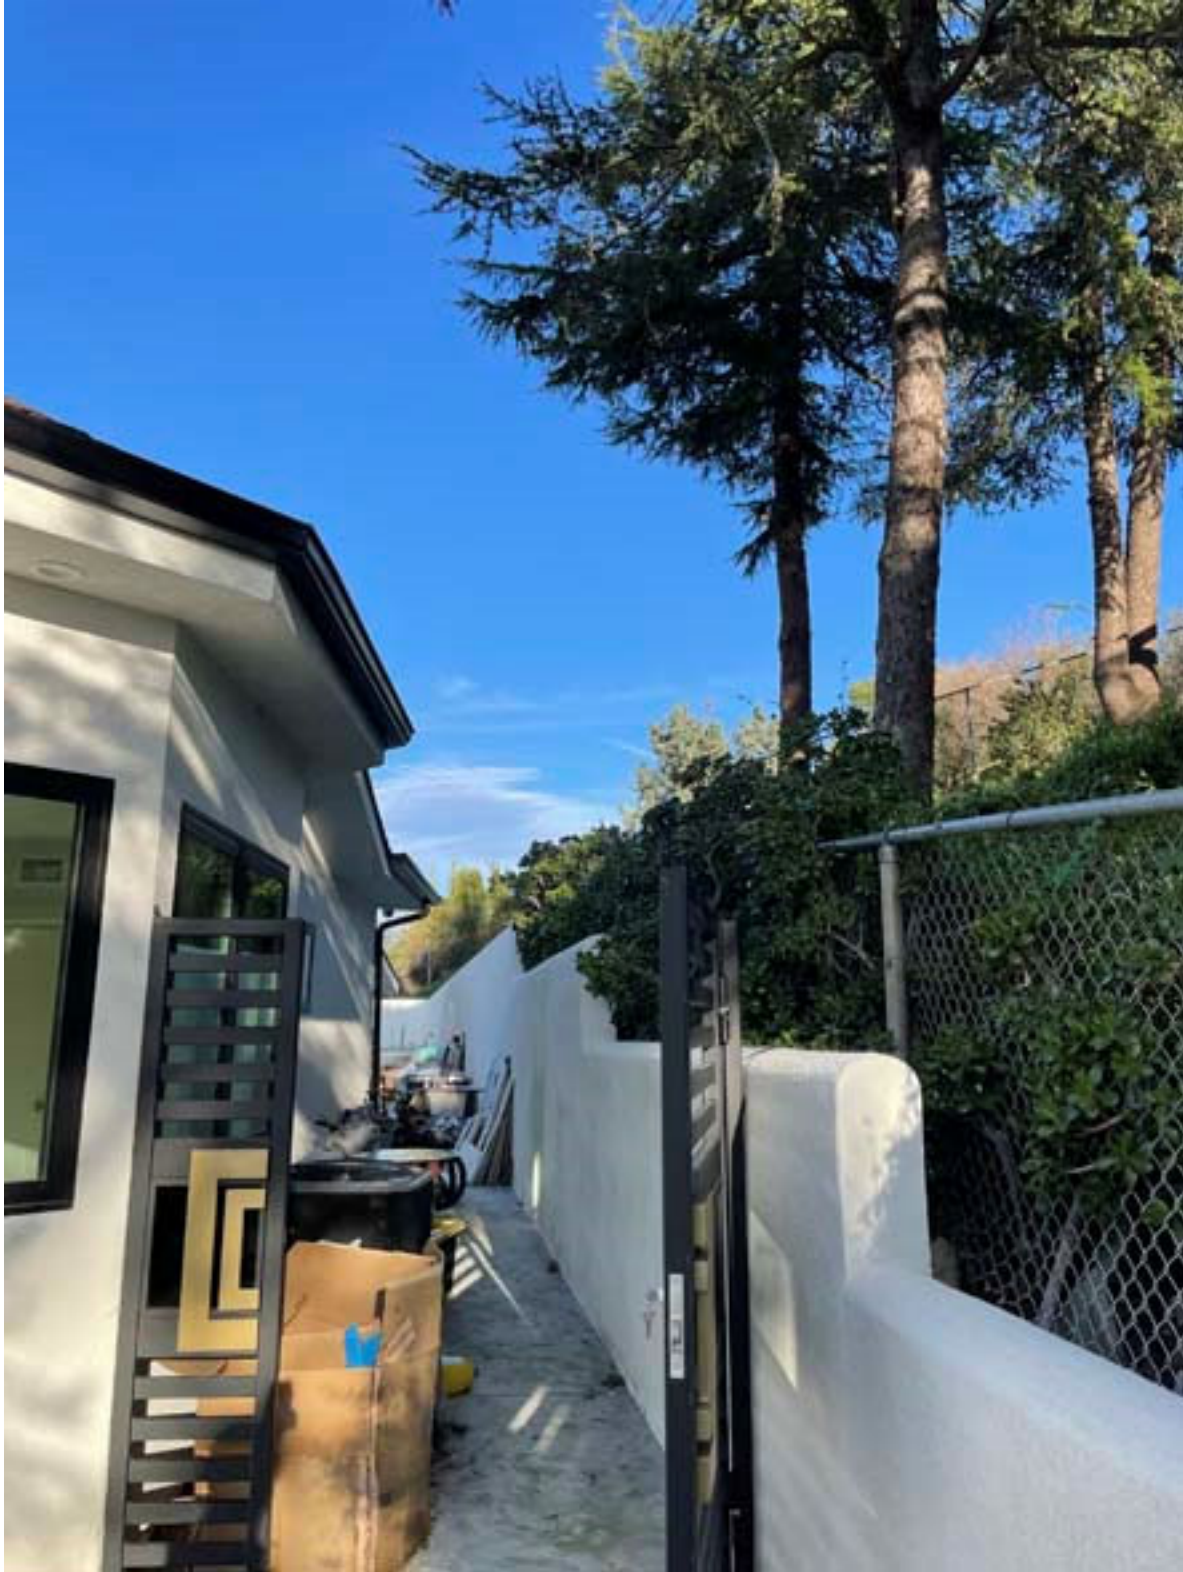
One unprotected pine tree was removed in 2020 due to concerns over the risk it posed. I observed no other evidence of tree removals prior to my site visit. Two unprotected cedar trees on the neighboring property to the south were encroached upon by the construction access route. However, the access route did not likely impact the trees because it was separated from the trees by a retaining wall and because it passed over existing hardscape that remained in place.

**Figure 24:** Looking east along the southern property line. A retaining wall separates Trees OP17, OP18, and OP19 from the area where construction work occurred.

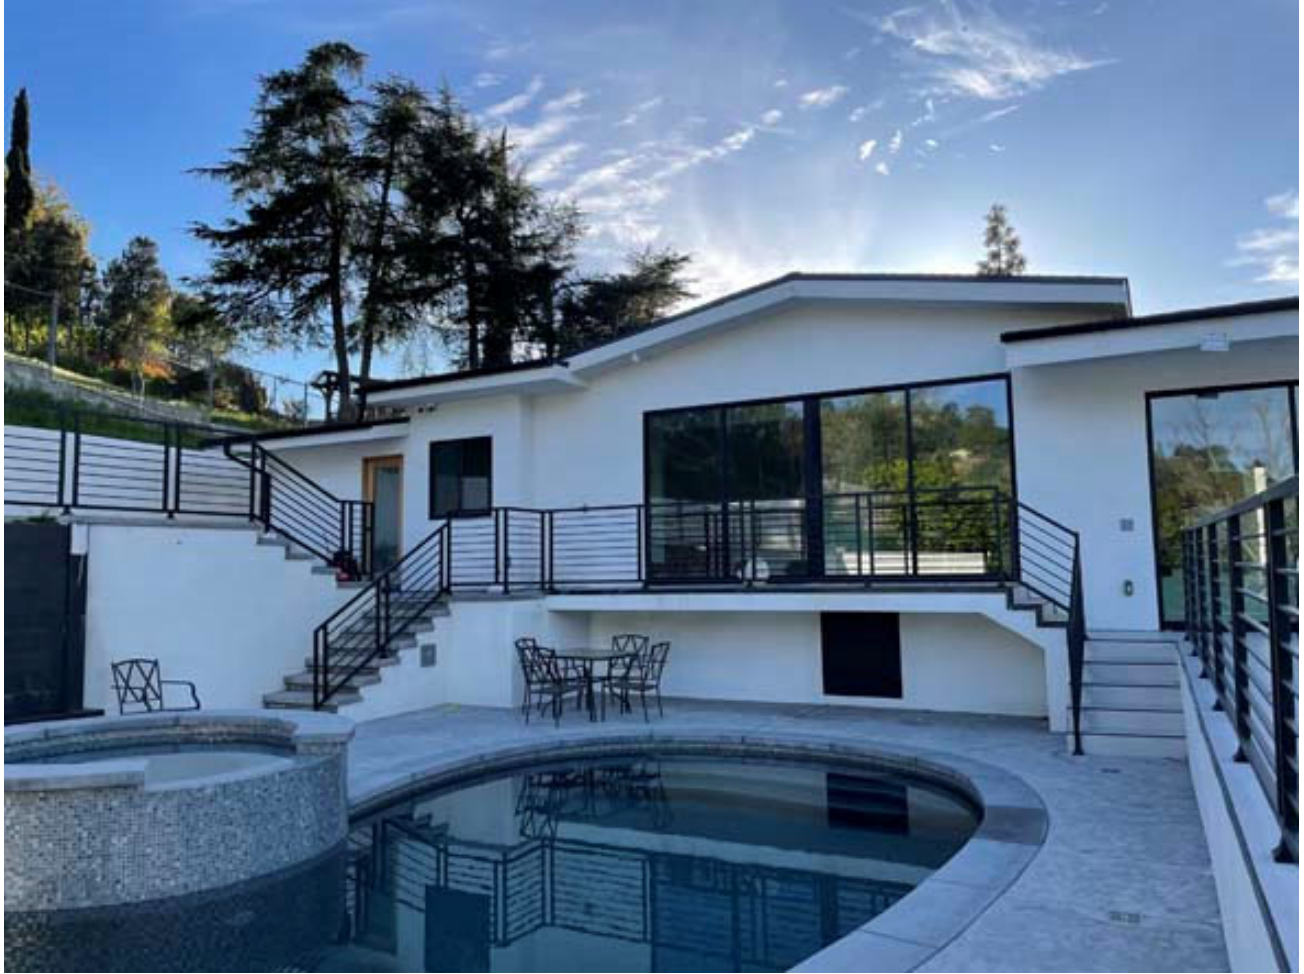
**Figure 25:** Looking southwest at the rear addition. No trees were near the area of addition.
