# 9604 Hillhaven Ave. Arborist Report

Prepared for SEC Development  
c/o Vardan Kasemyan

**Prepared by James Komen**  
BCMA WE-9909B  
RCA #555

April 14, 2023

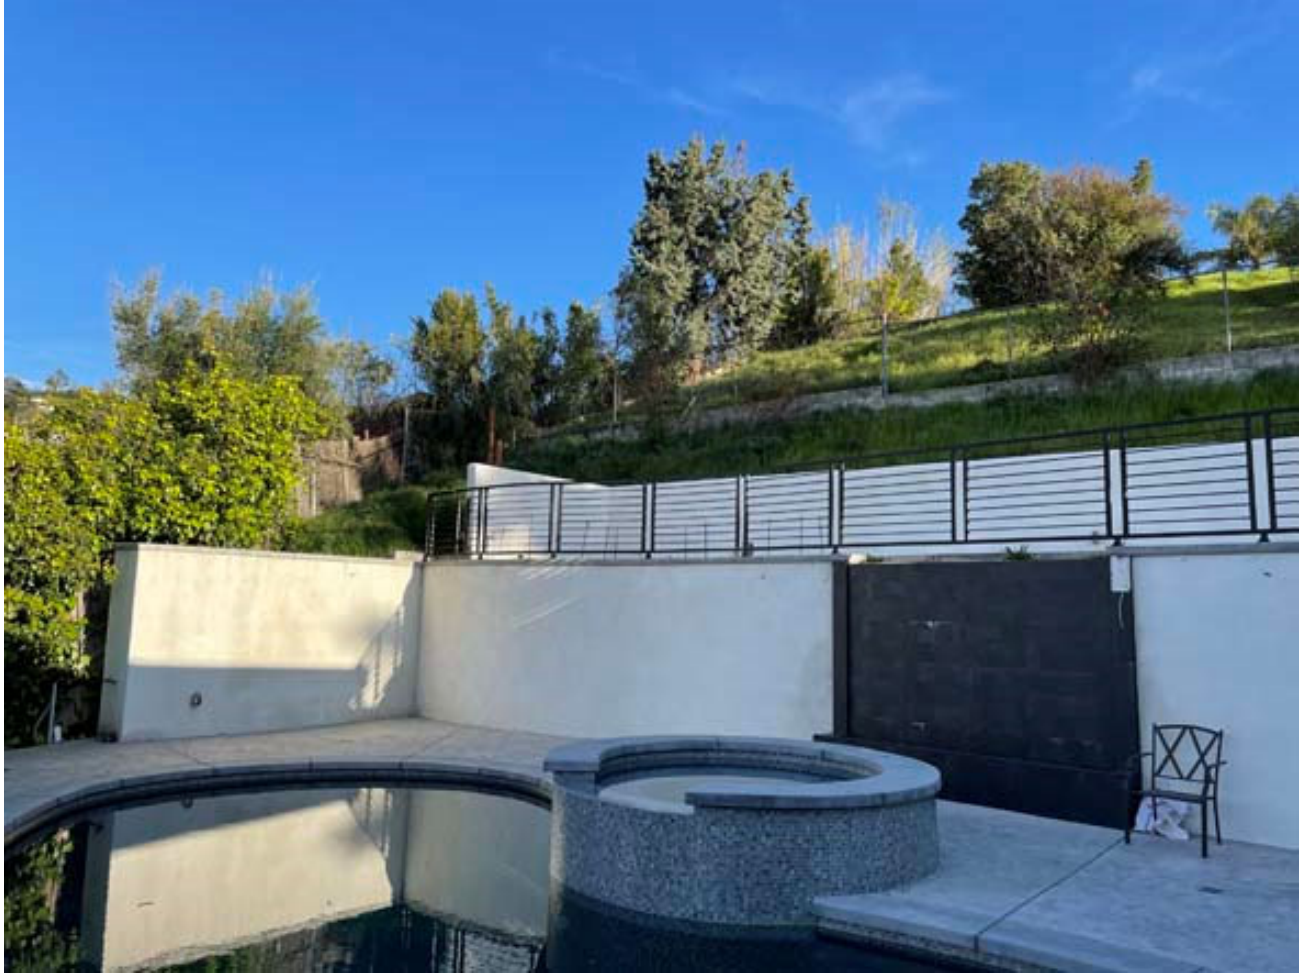
**Figure 26:** Looking southeast at the rear corner of the property. There are no trees.

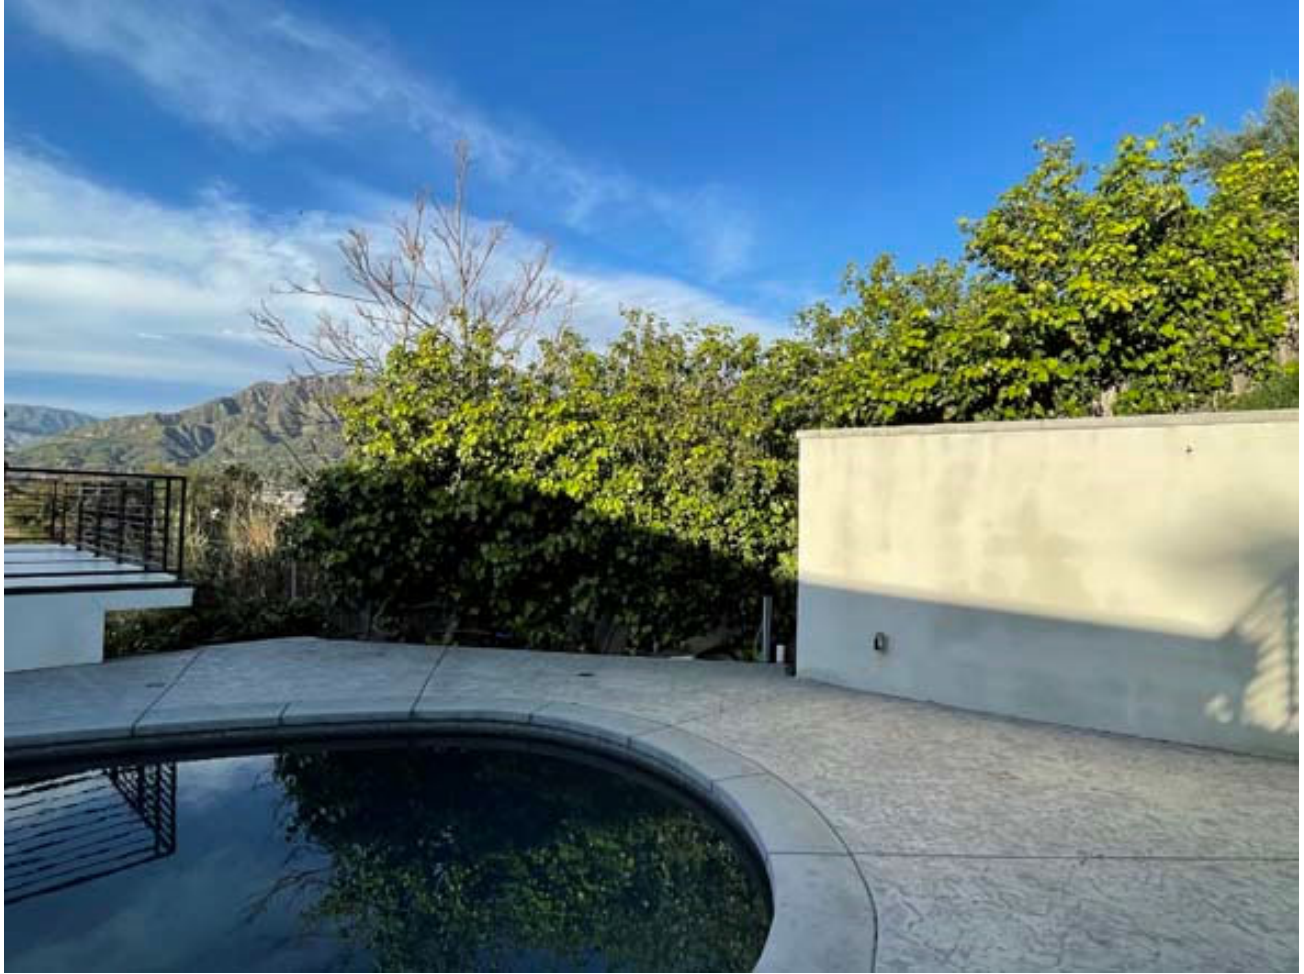
**Figure 27:** Looking northeast at the east property line. The top of Tree OP16 can be seen above the English ivy hedge on the fenceline.
